FINAL PROJECT REPORT

Grantee: Alameda County Water District
Title: Old Jarvis Road Irrigation Well Destruction Project
Agreement No.: D1712501
Date: March 30, 2022
Project Type: Groundwater Implementation
Total Project Cost: \$413,931.00

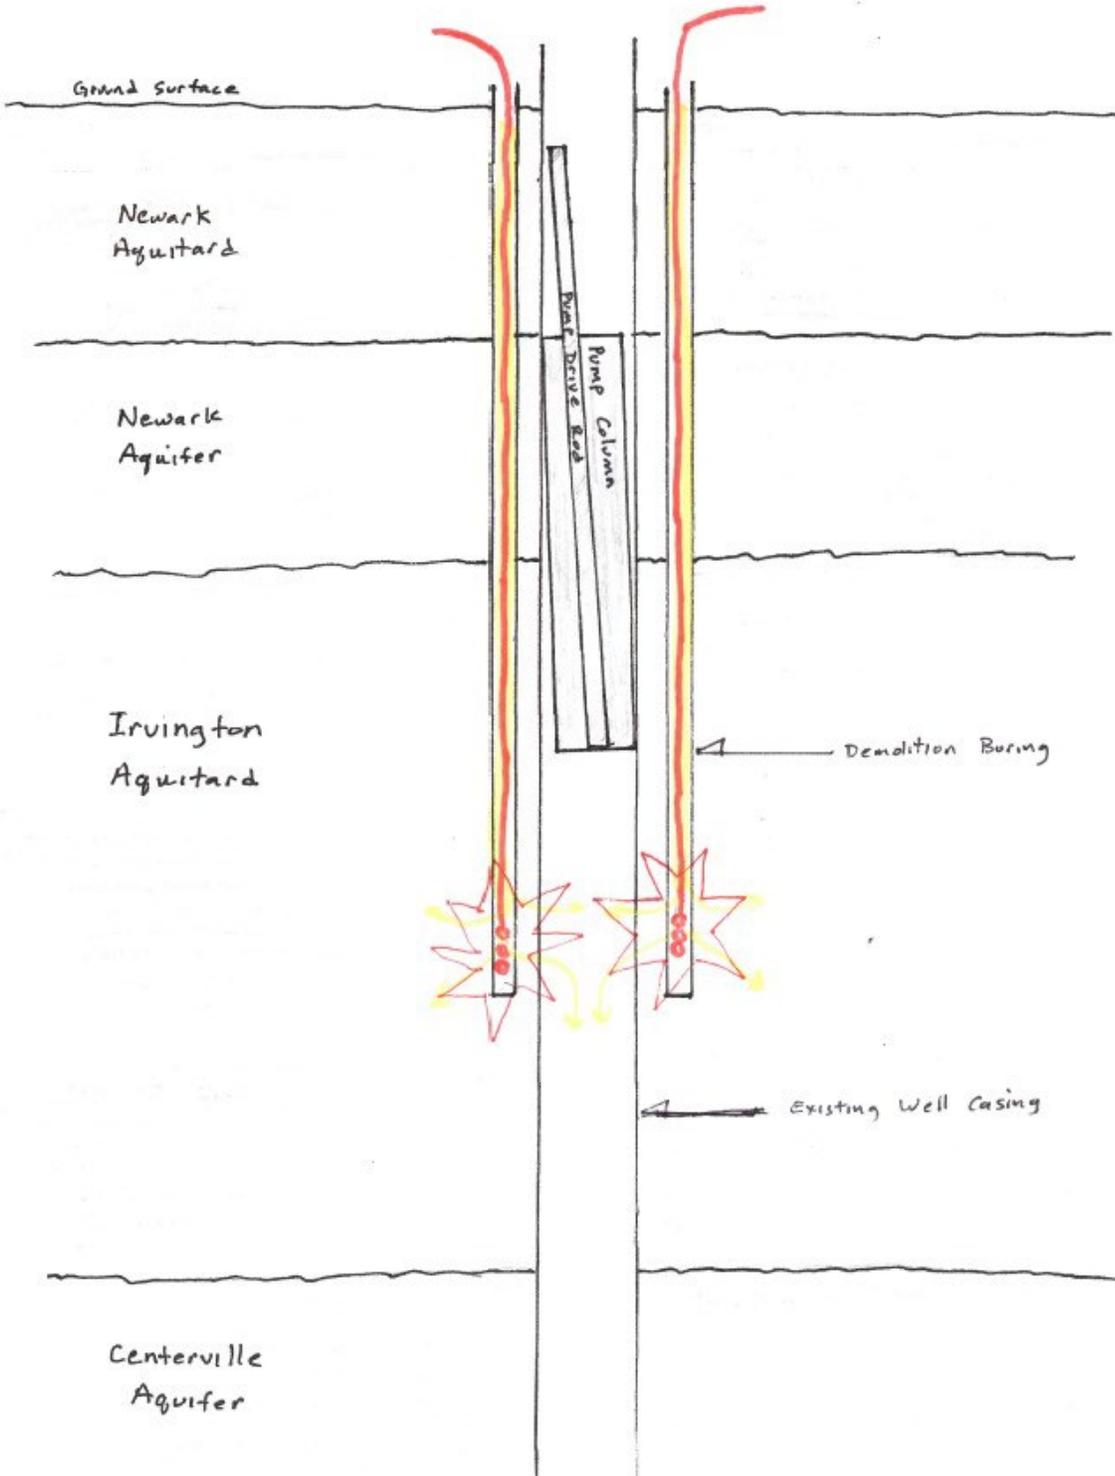
Figure 2. Conceptual Drawing for Alternate Destruction Approach for Well D005

1. Leaving the casing as-is and sealing the upper portion of the well;
2. Drilling out the cement and steel in the well with a steel cutting bit and powerful drill rig;
3. Drilling a larger-diameter casing around the well and attempting to loosen the casing to a point where it could be pulled; and
4. Destroying the well from the outside by drilling between 4-6 boreholes around the well, installing barrier casing, add demolition charges, and perforating the casing from the outside.

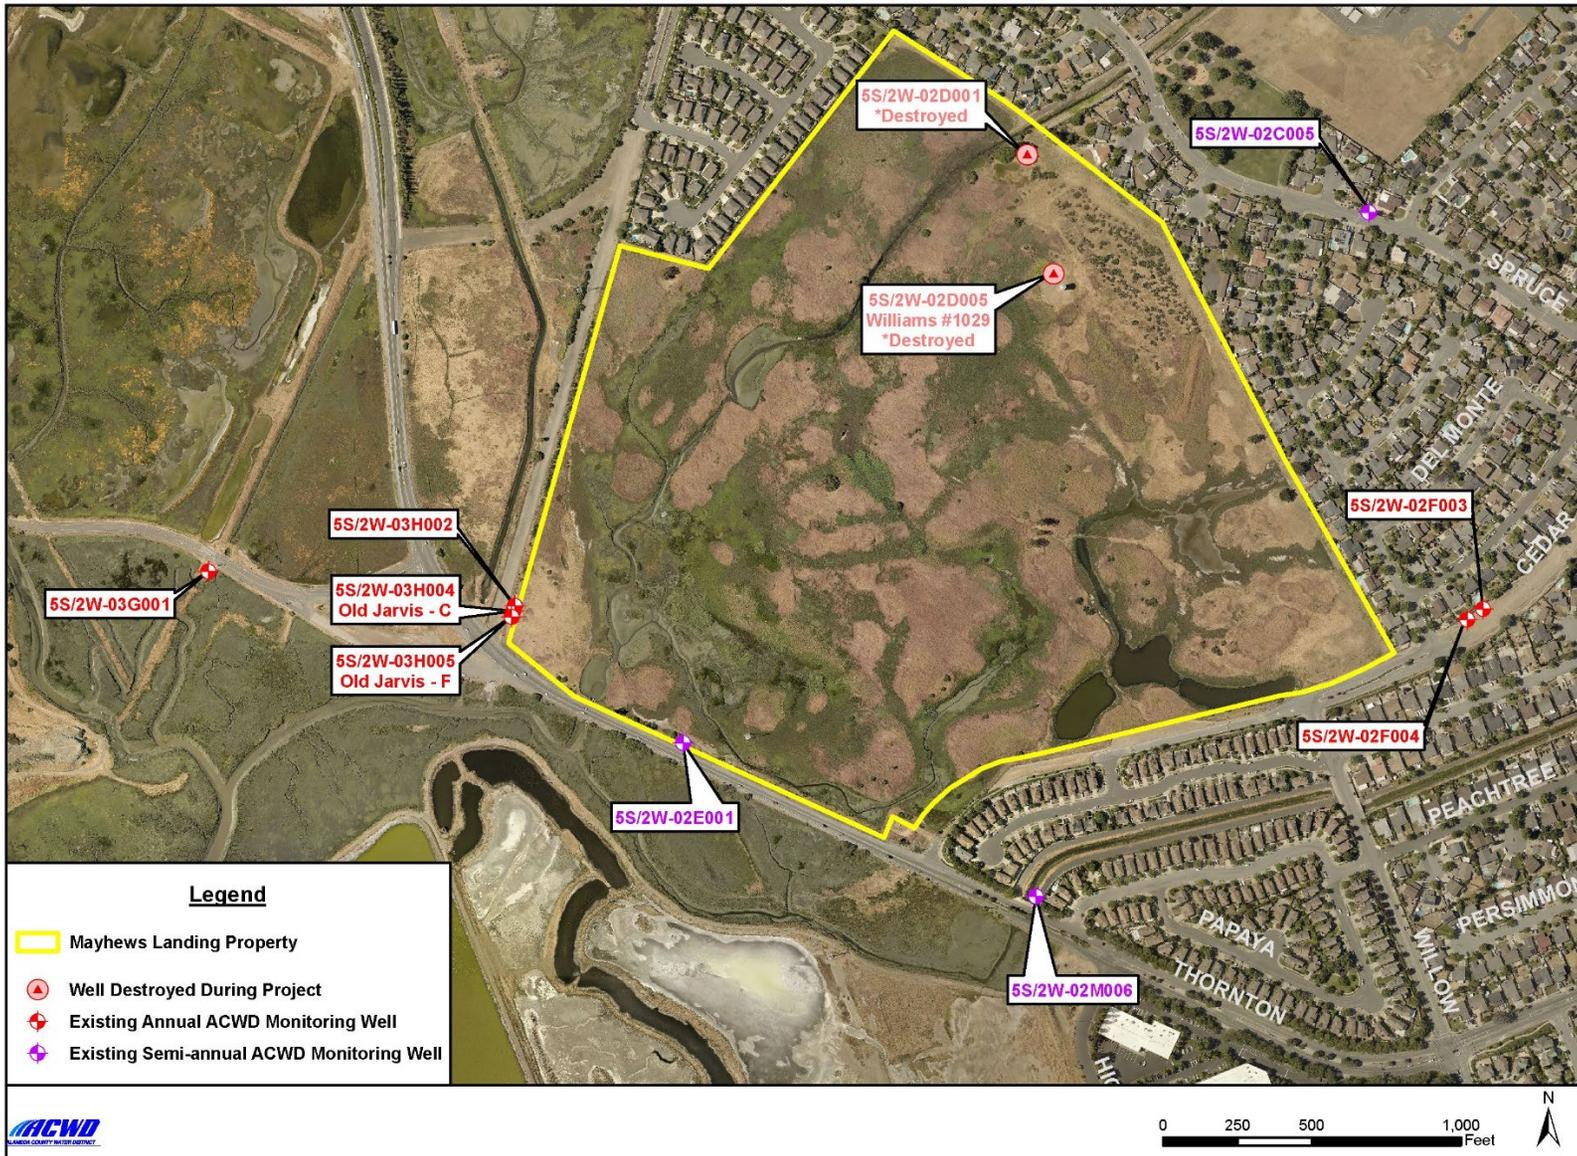
Existing wells in ACWD's monitoring well network will be sampled during ACWD's semiannual monitoring program. Monitoring wells screened in the lower aquifers will be analyzed for chlorides to evaluate the ongoing effectiveness of the Project. See [Figure 3](#) for the locations of monitoring wells in ACWD's existing monitoring network that will be sampled for chlorides during ACWD's semiannual groundwater monitoring program. These wells were chosen due to their proximity to – and, therefore, their potential to be in hydraulic communication with – Well D001 and Well D005. Ongoing sampling of these monitoring wells will achieve one of the Project goals to assess the effectiveness of the Project on improving groundwater quality.

Figure 3. Existing Wells in ACWD Monitoring Well Network Located in the Vicinity of the Project Site

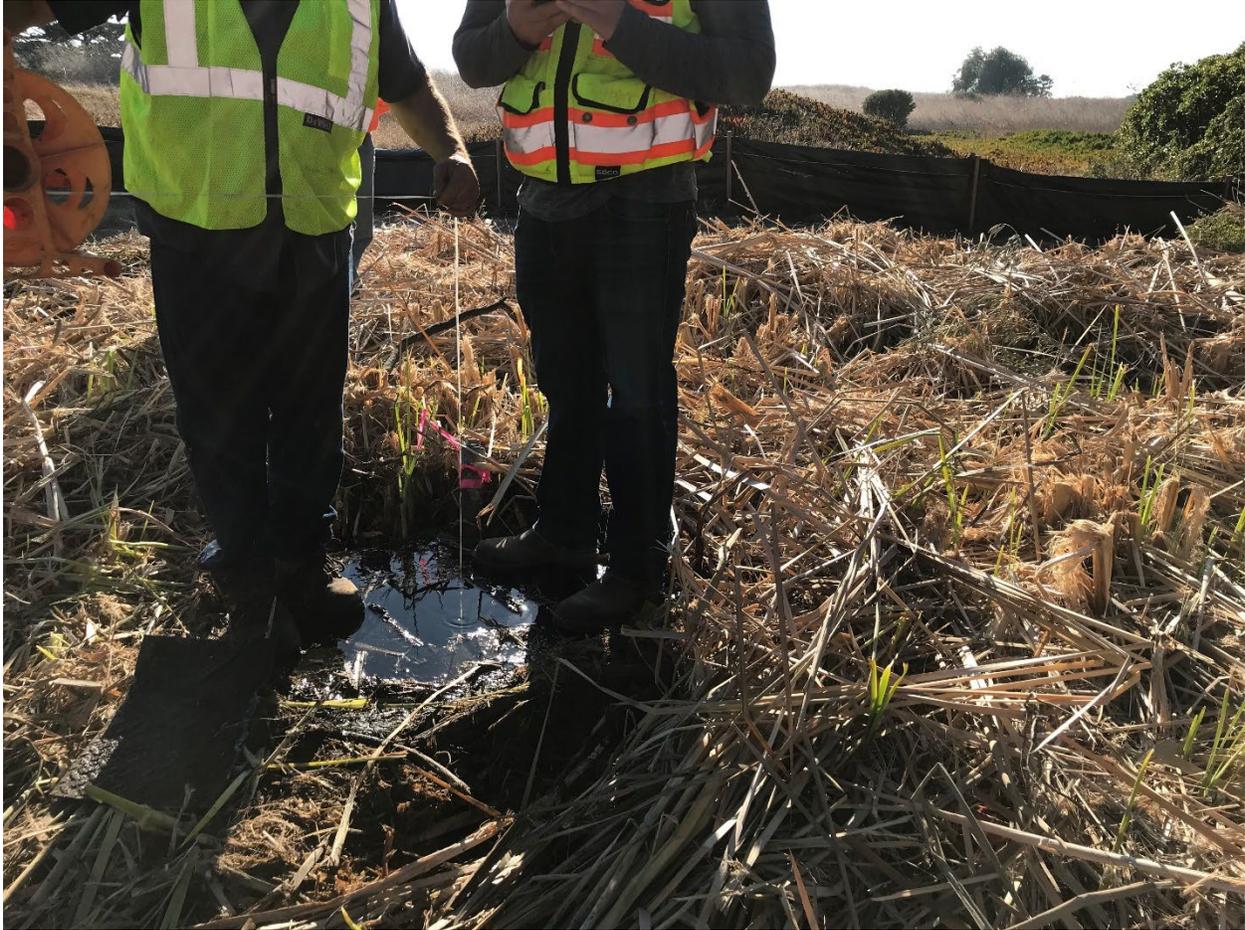
On December 22, 2020, Well D001 was tagged to 423 feet below ground surface (bgs) and video logged. Because the original depth of the well is assumed to be 450 feet bgs, the tagged depth indicated the presence of approximately 27 feet of slough material. The video log for Well D001 showed the casing was open and clear. The well column pipe was removed at 167 feet bgs from Well D001 on December 23, 2020. All column pipe, line shaft rod, and submersible pump were removed from Well D001 with a smear rig on January 4 and 5, 2021. An oily sheen was observed in the water emanating from Well D001 on January 4, 2021.

Photograph 10: Tagging the depth of Well D001.

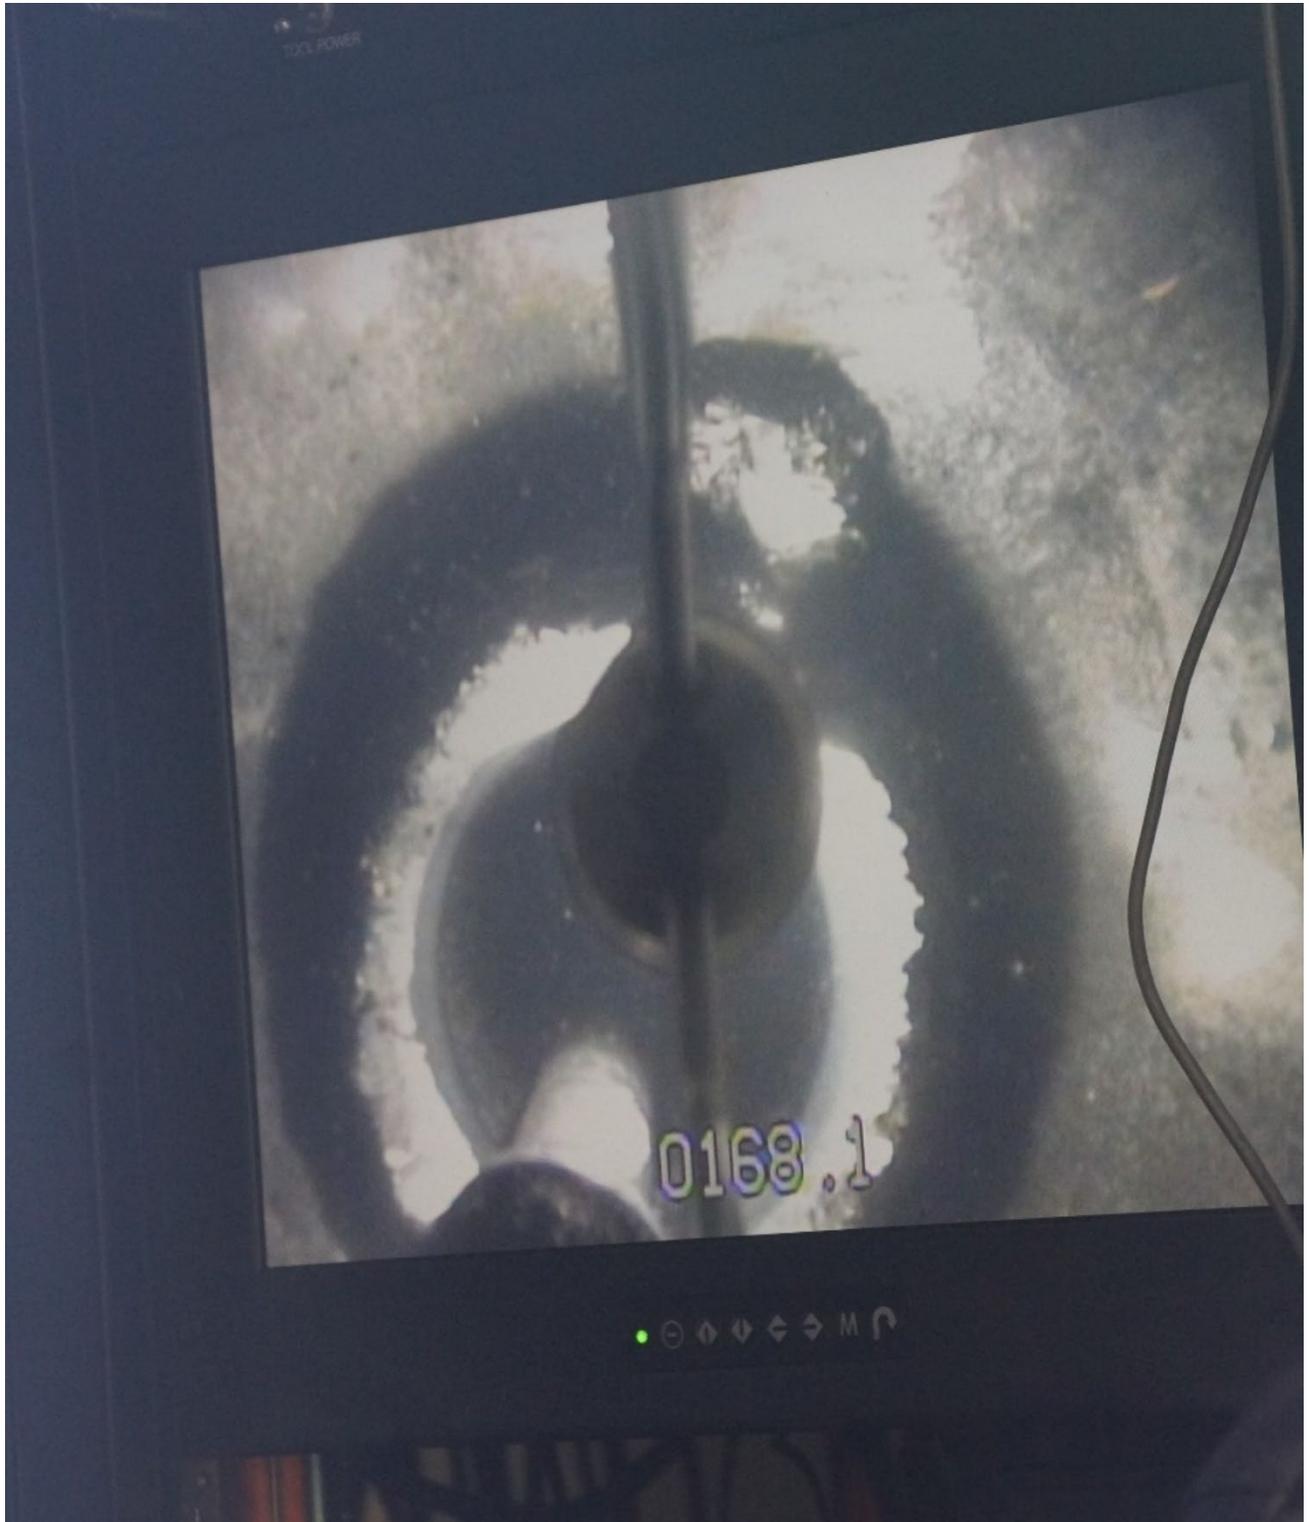
Photograph 16: View of video feed during video logging at Well D001.

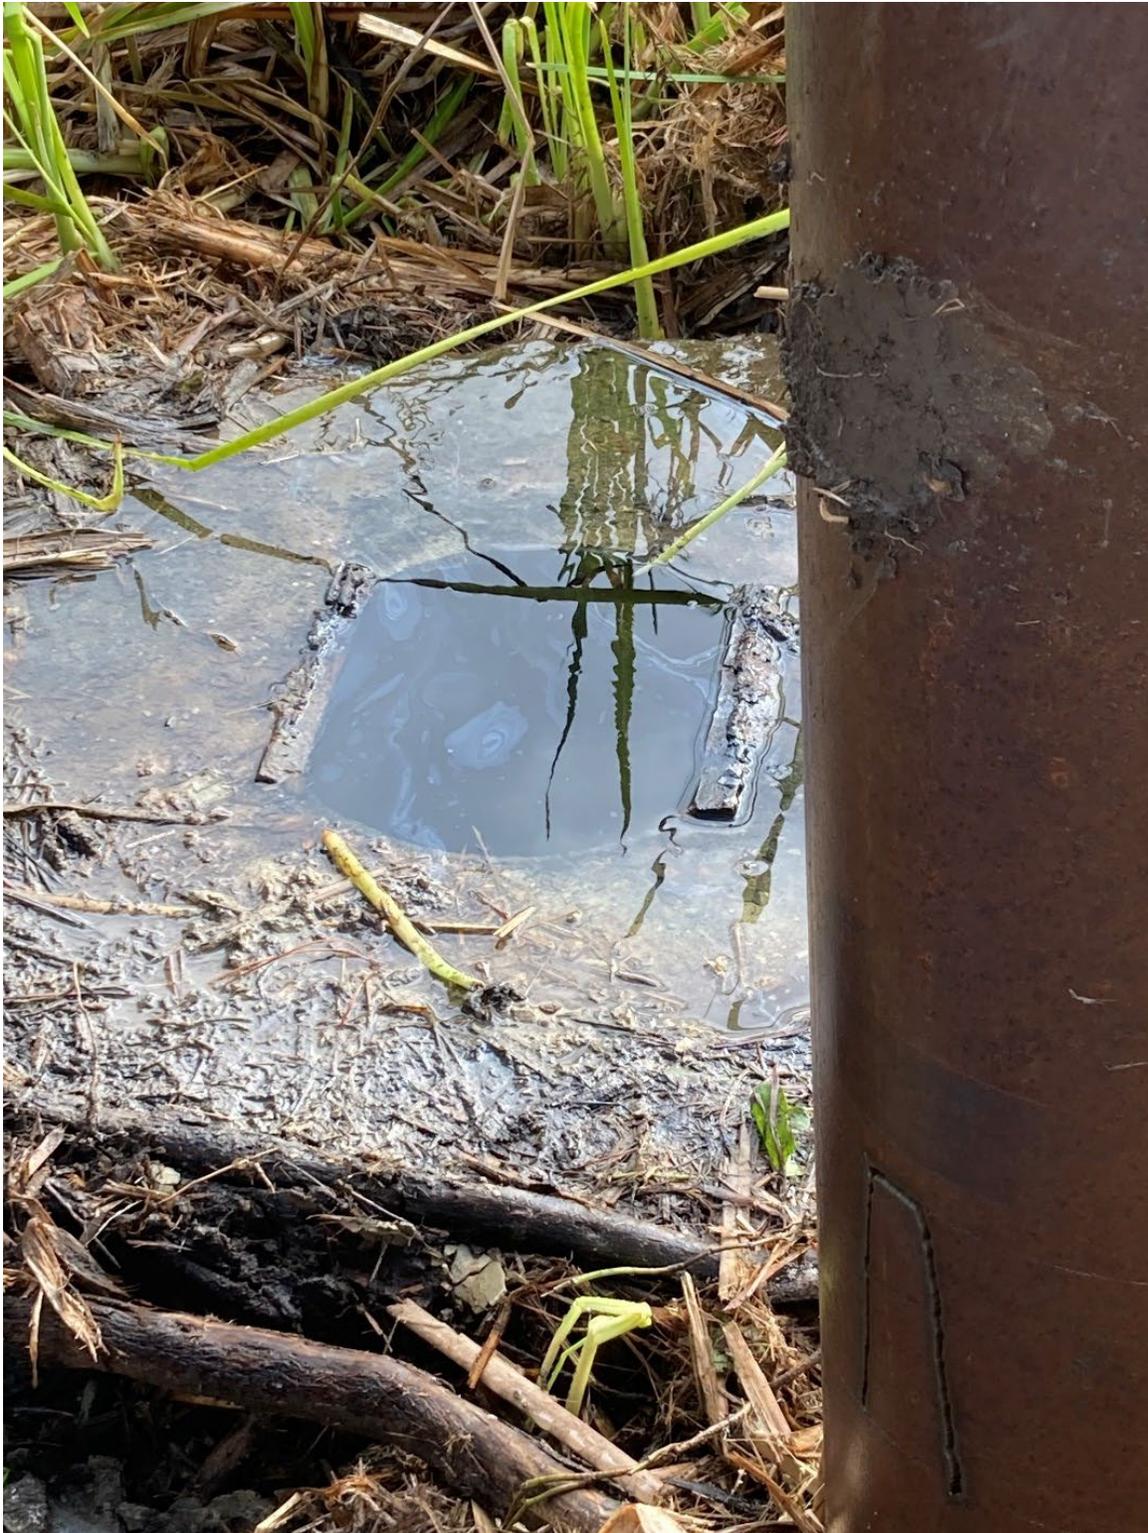
Photograph 23: View of Well D001; an oily sheen was observed in the water emanating from Well D001.

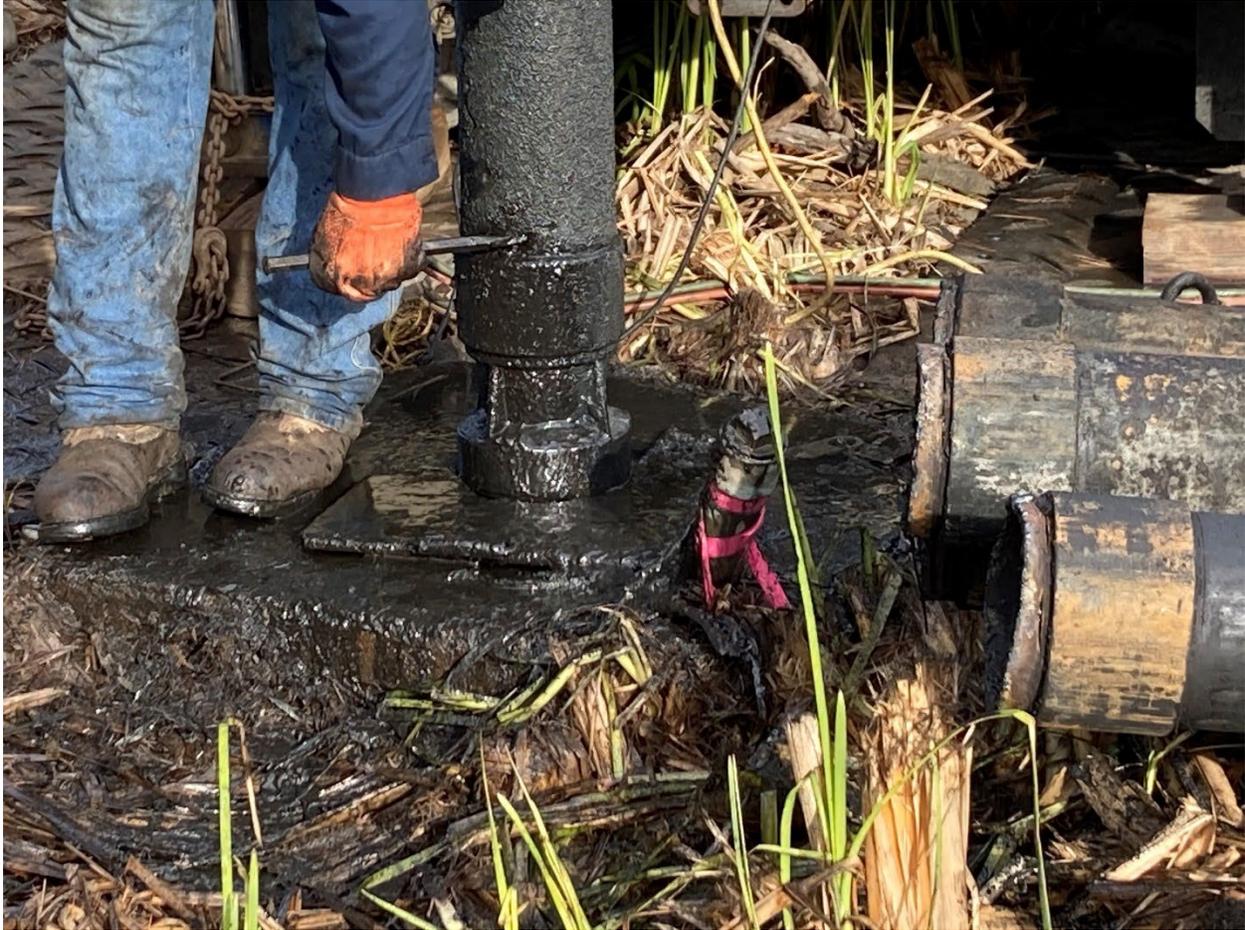
Photograph 27: Oil flows from the pipe during removal of final column pipe from Well D001 near pump bowl assemblies.

On January 7, 2021, 4-inch steel airlift piping and 1.25-inch air hose were installed into Well D001 and used to airlift water to an onsite wastewater tank due to the presence of oil. Per recommendation from NorCal

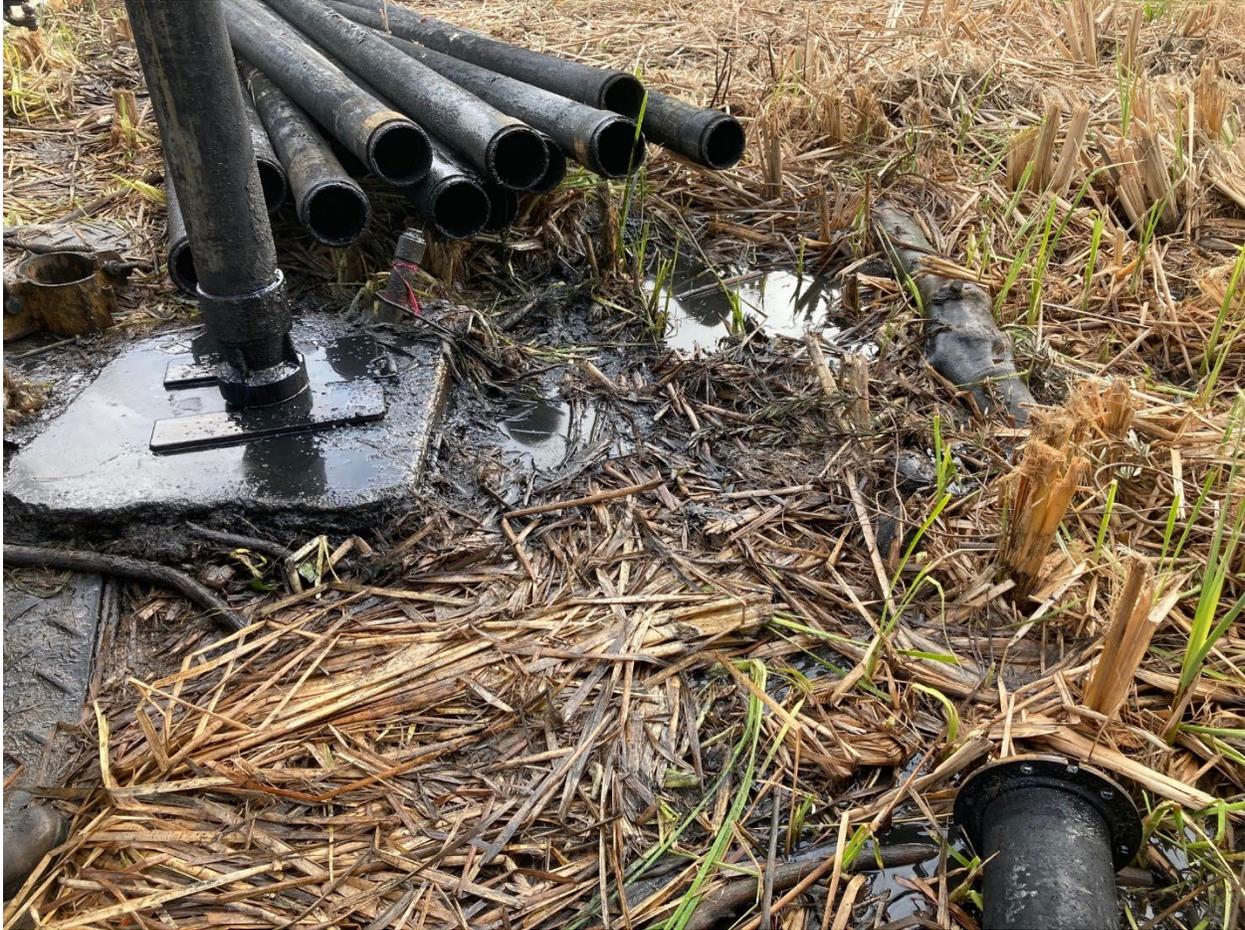
Photograph 28: View of impacted water that had flowed from final column pipe at Well D001.
Final Project Report, Old Jarvis Road Irrigation Well Destruction Project

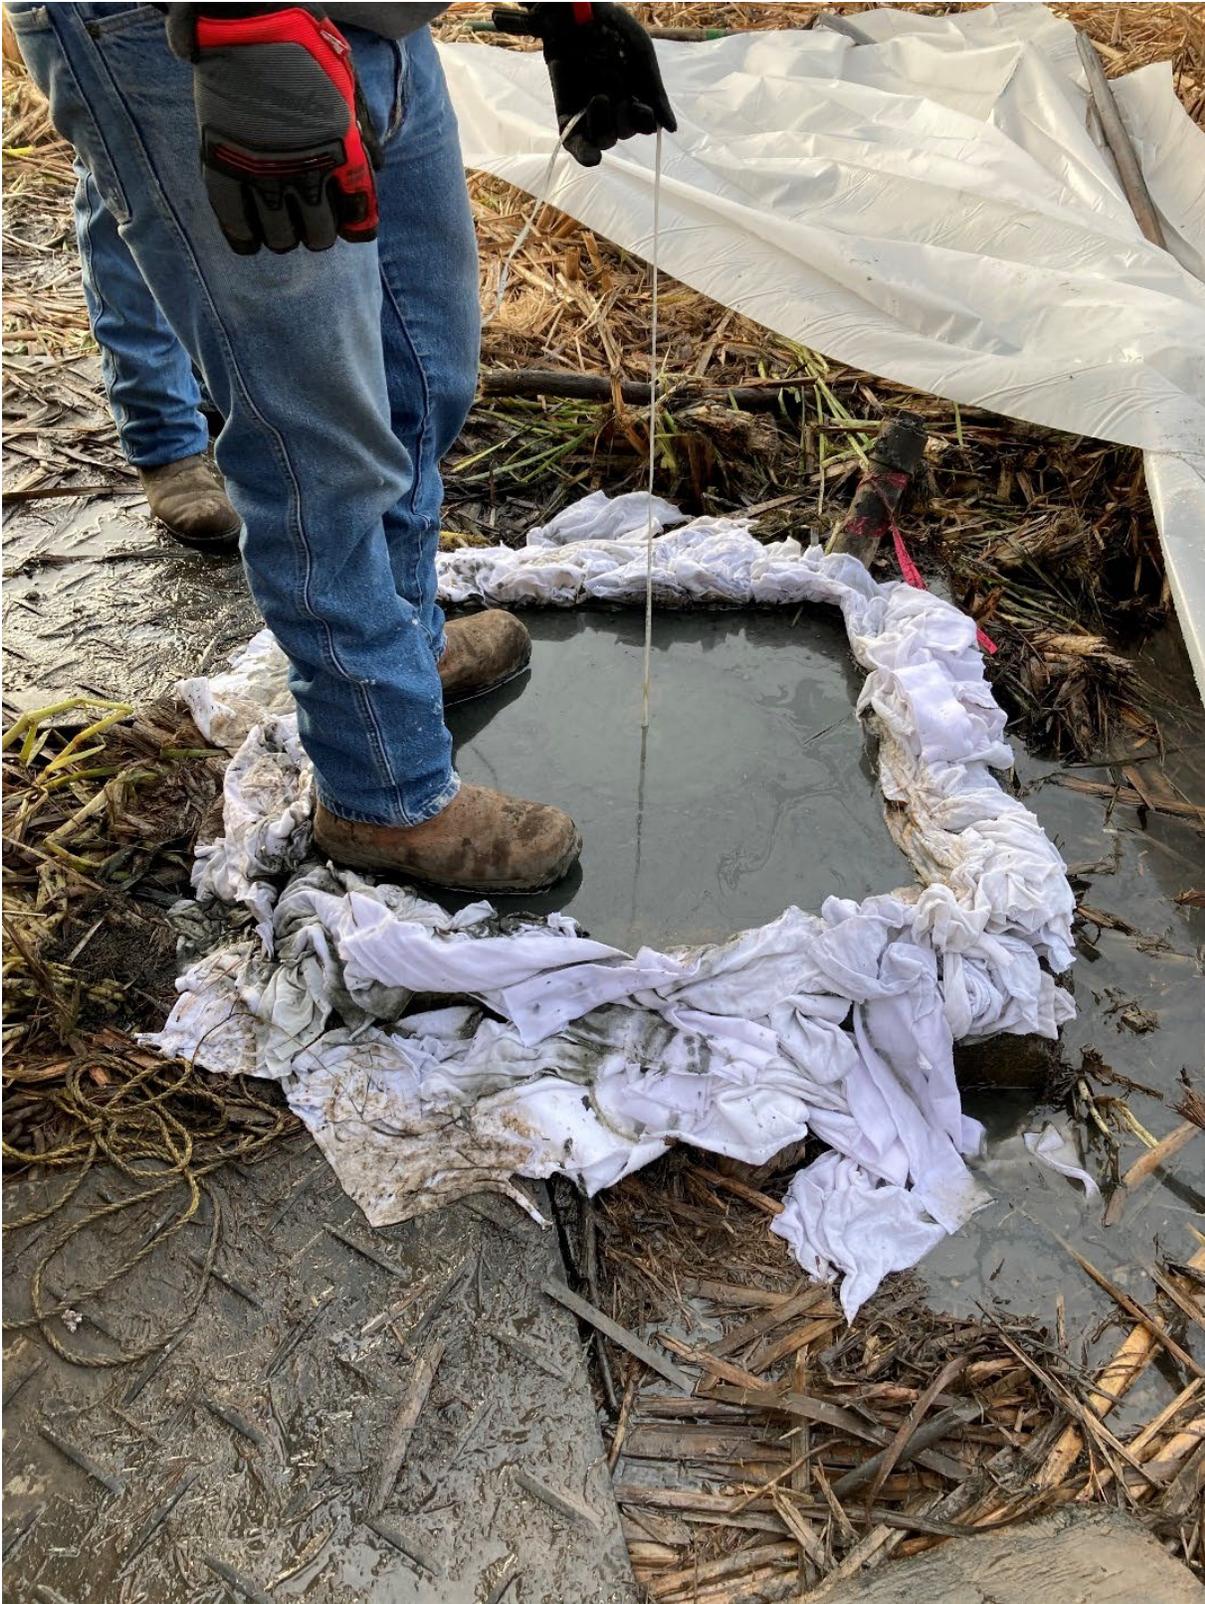
Photograph 41: View of Well D001; note oily sheen on water emanating from the well.

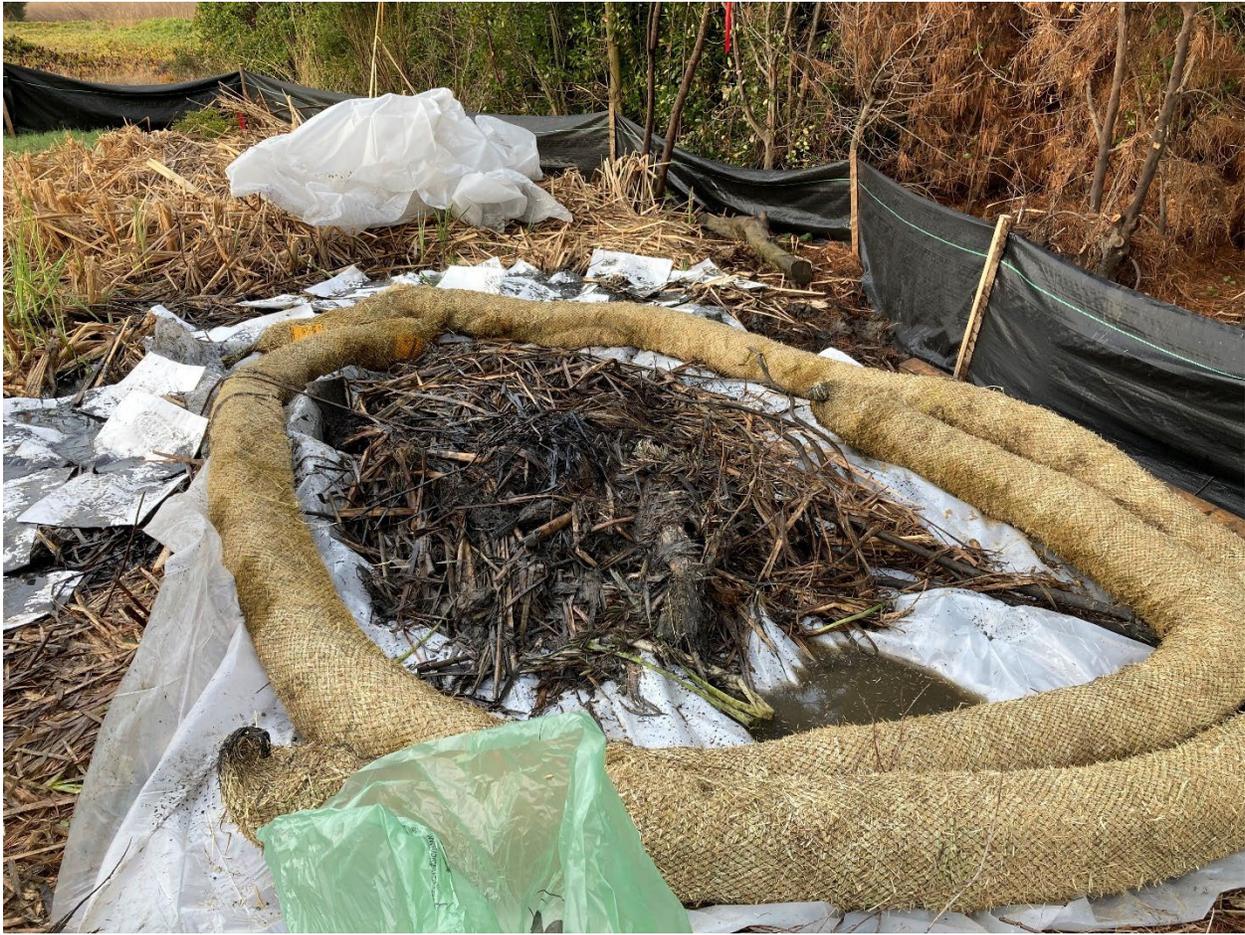
Photograph 42: Absorbent pads and plastic sheets used to contain impacted water at Well D001 site.

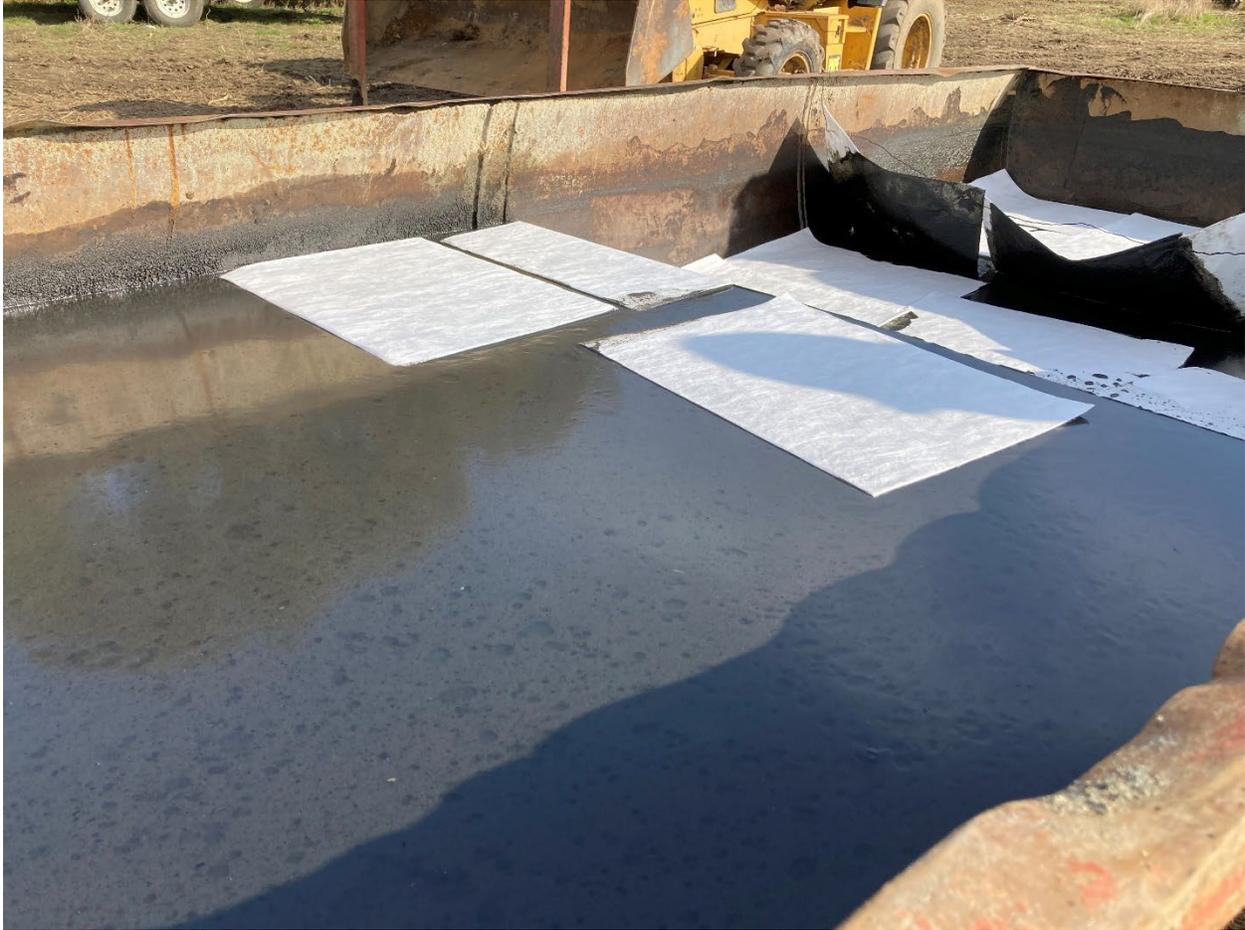
Photograph 45: Absorbent pads used to soak oil globules from onsite wastewater tank prior to discharge.

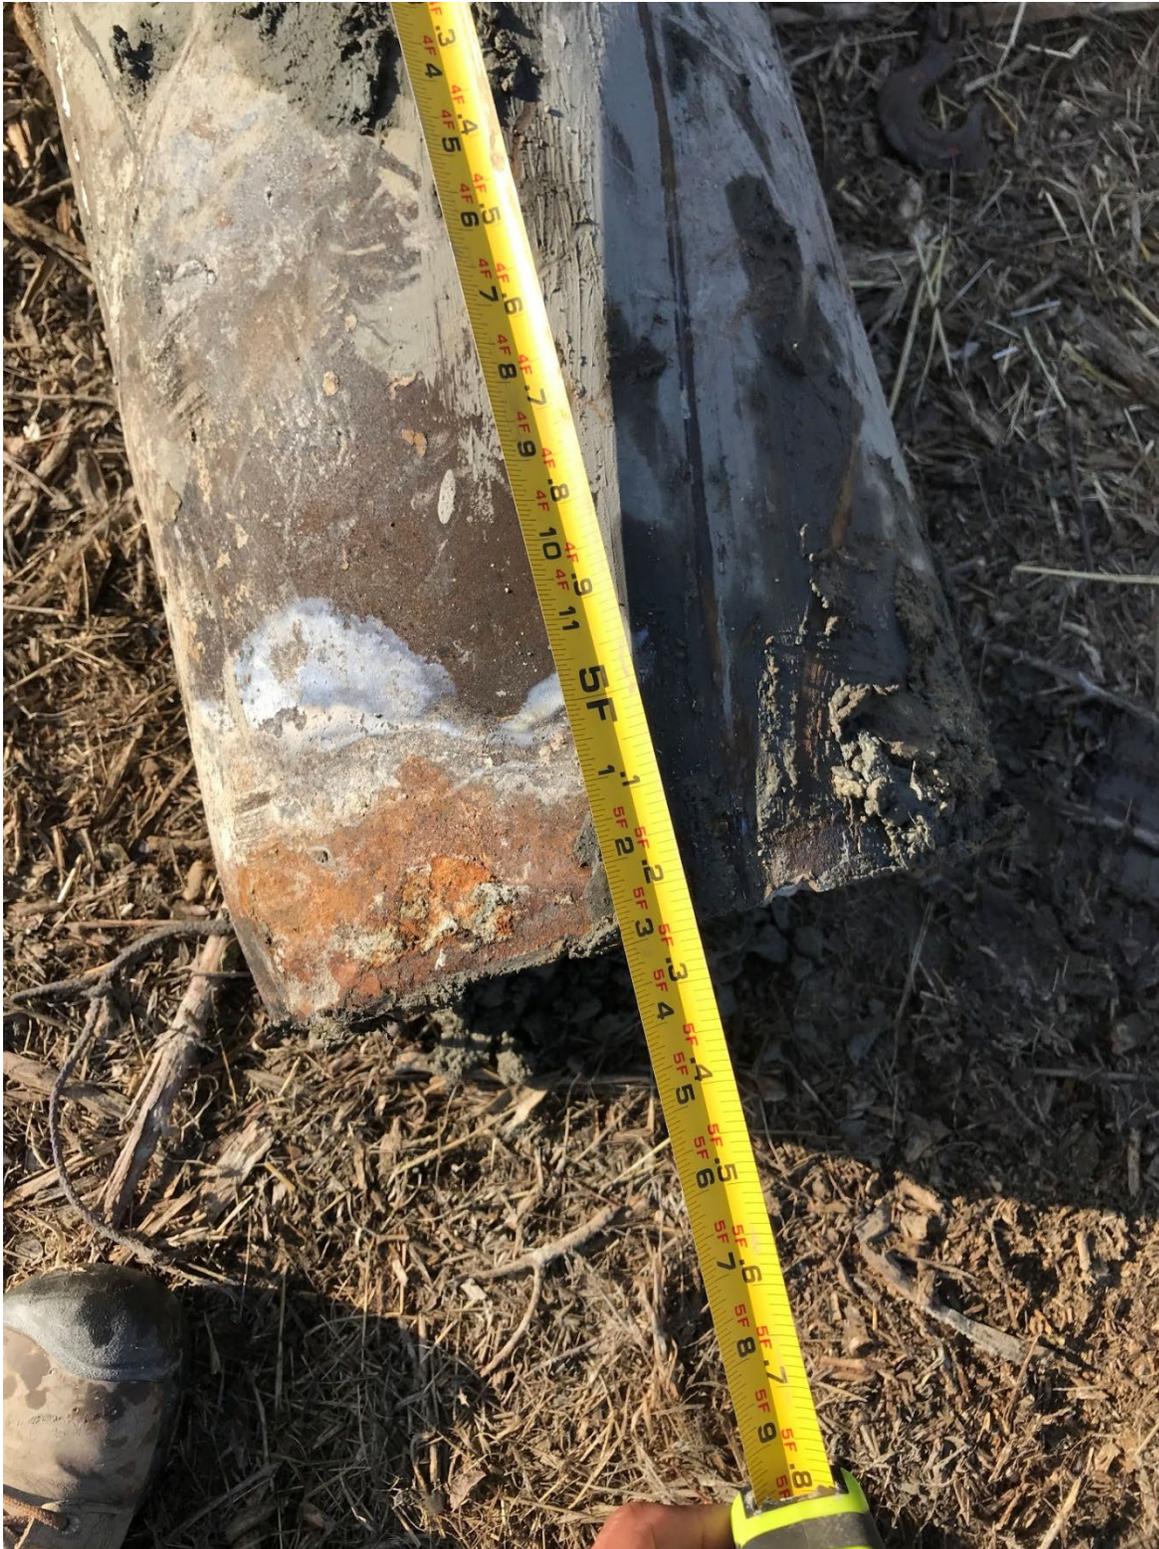
Photograph 58: View of top five feet of conductor casing removed from Well D001.

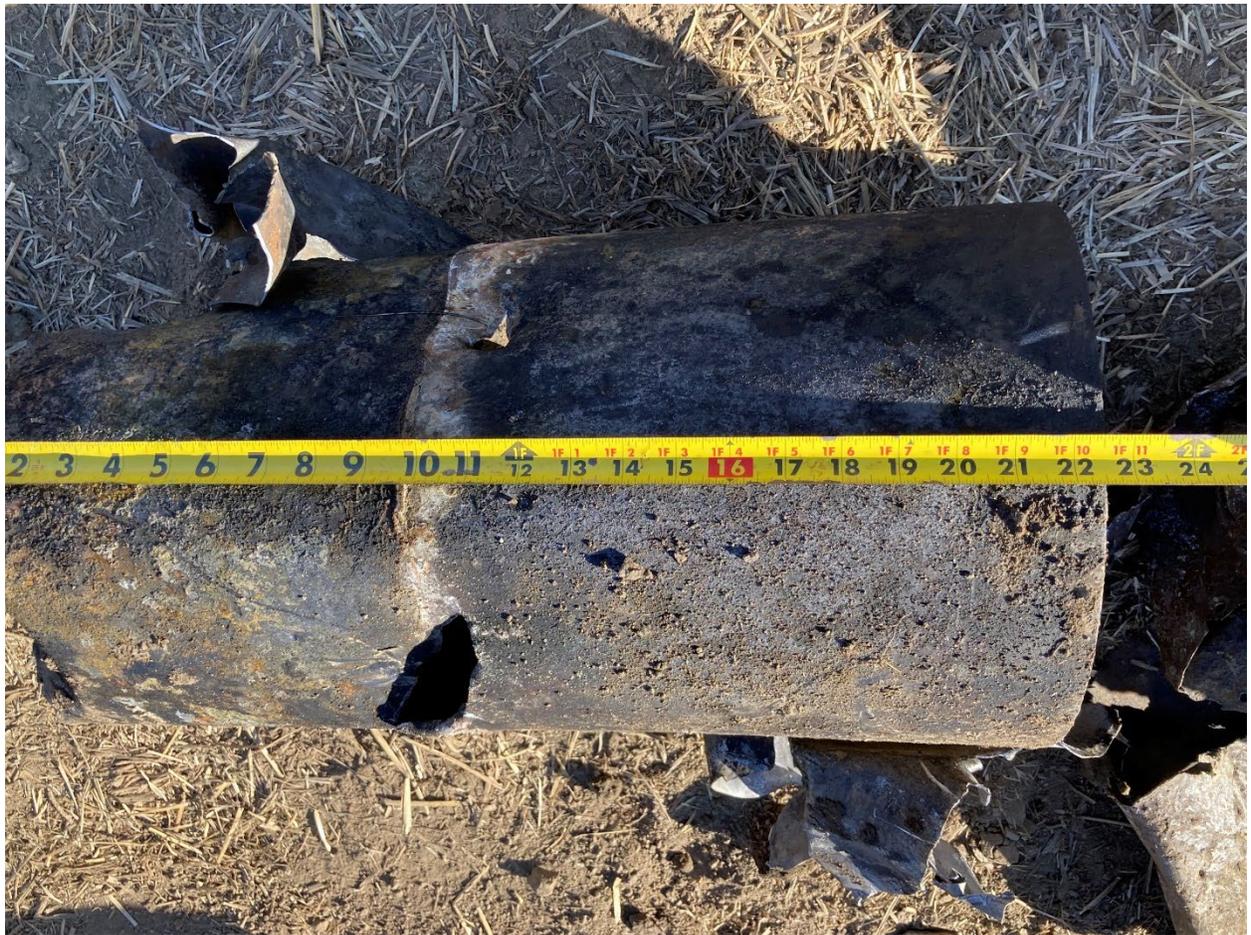
Photograph 77: Portion of pipe removed from Well D005.

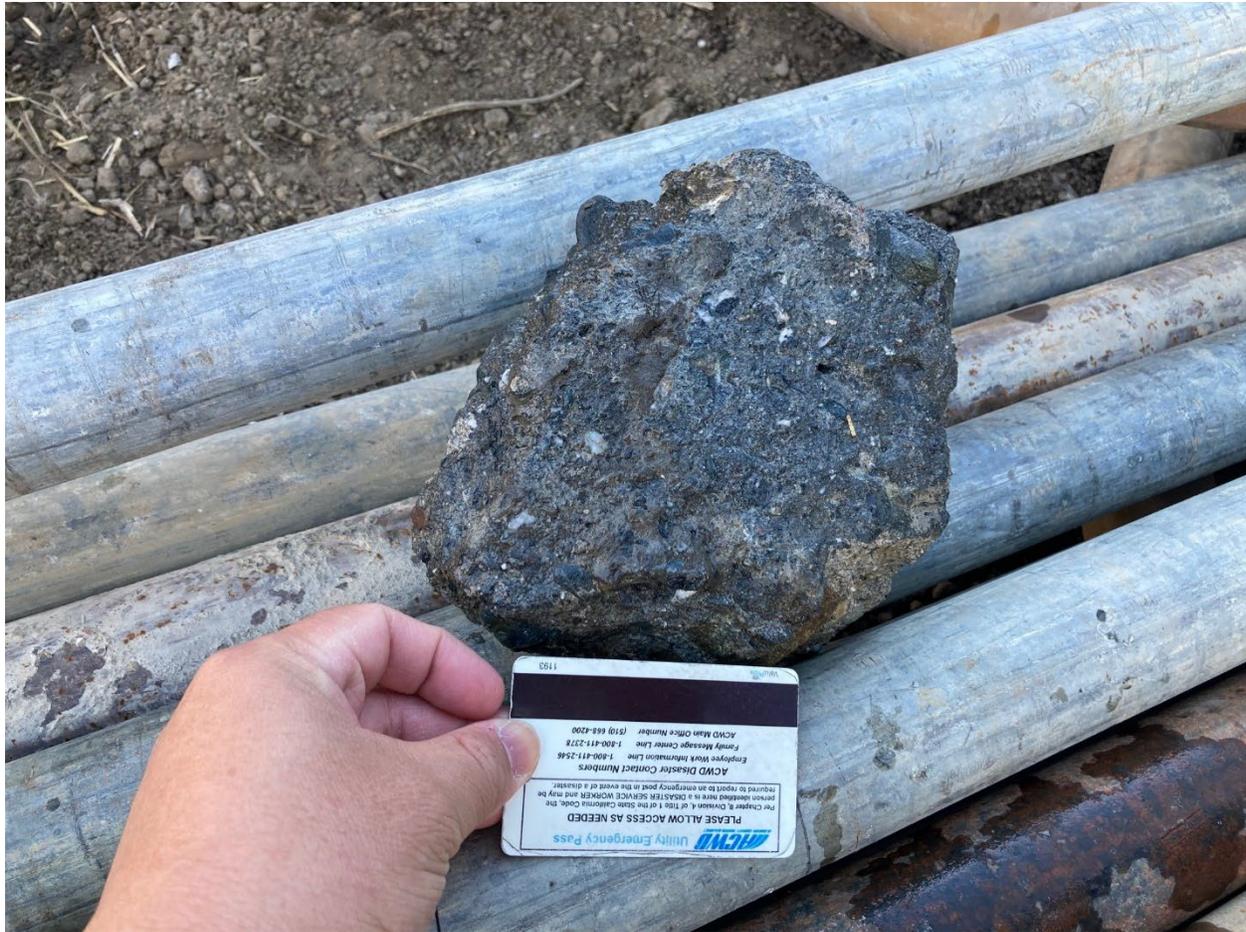
with broken concrete debris, and removal of the debris found an apparent pump drive shaft (approx. 2 feet below the well casing rim) and cement that appeared to have been poured in place (approx. 11 feet bgs).

Photograph 79: Concrete blockage encountered at Well D005 (ID card for scale).

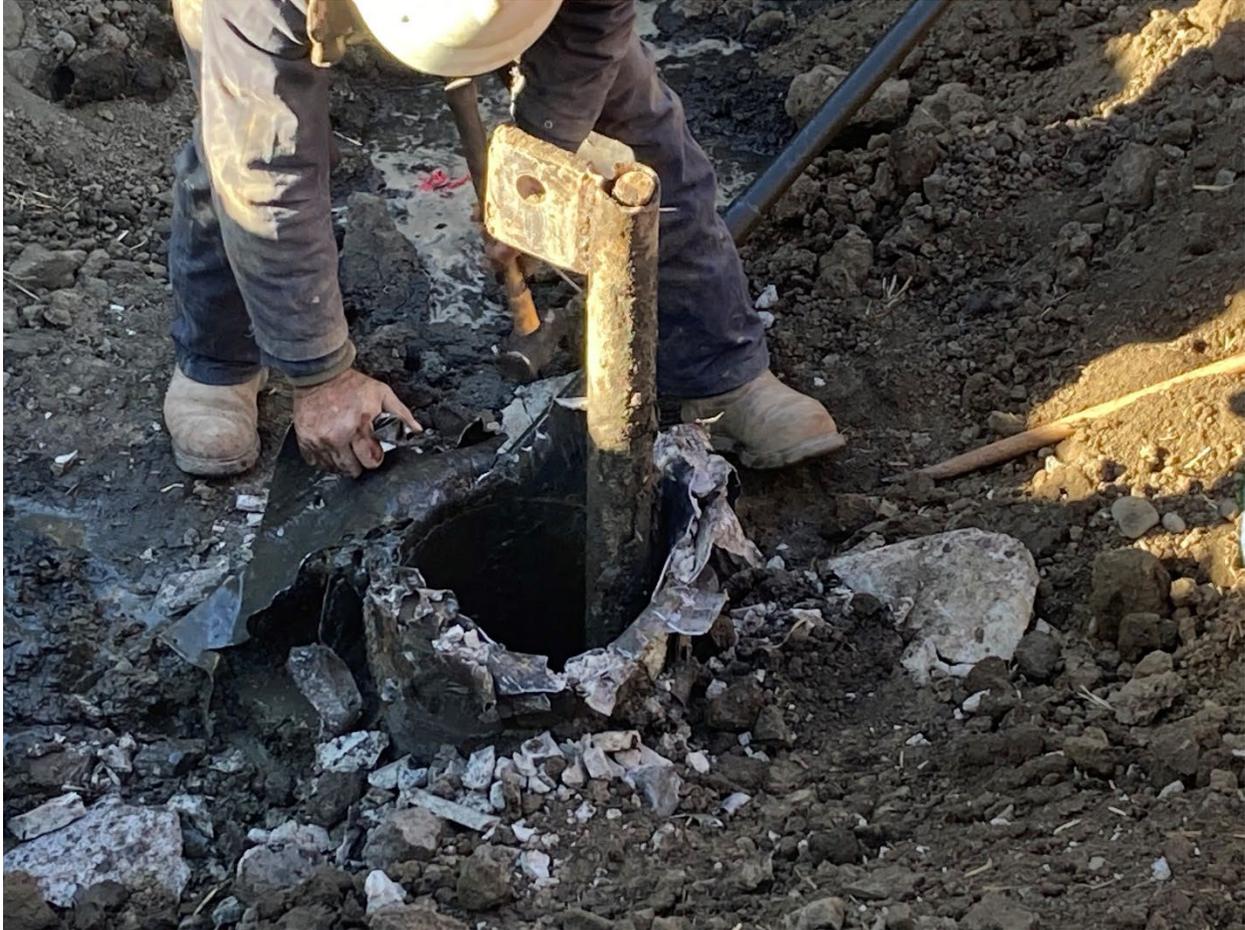
Photograph 80: Drilling contractor working to remove blockages encountered at Well D005.

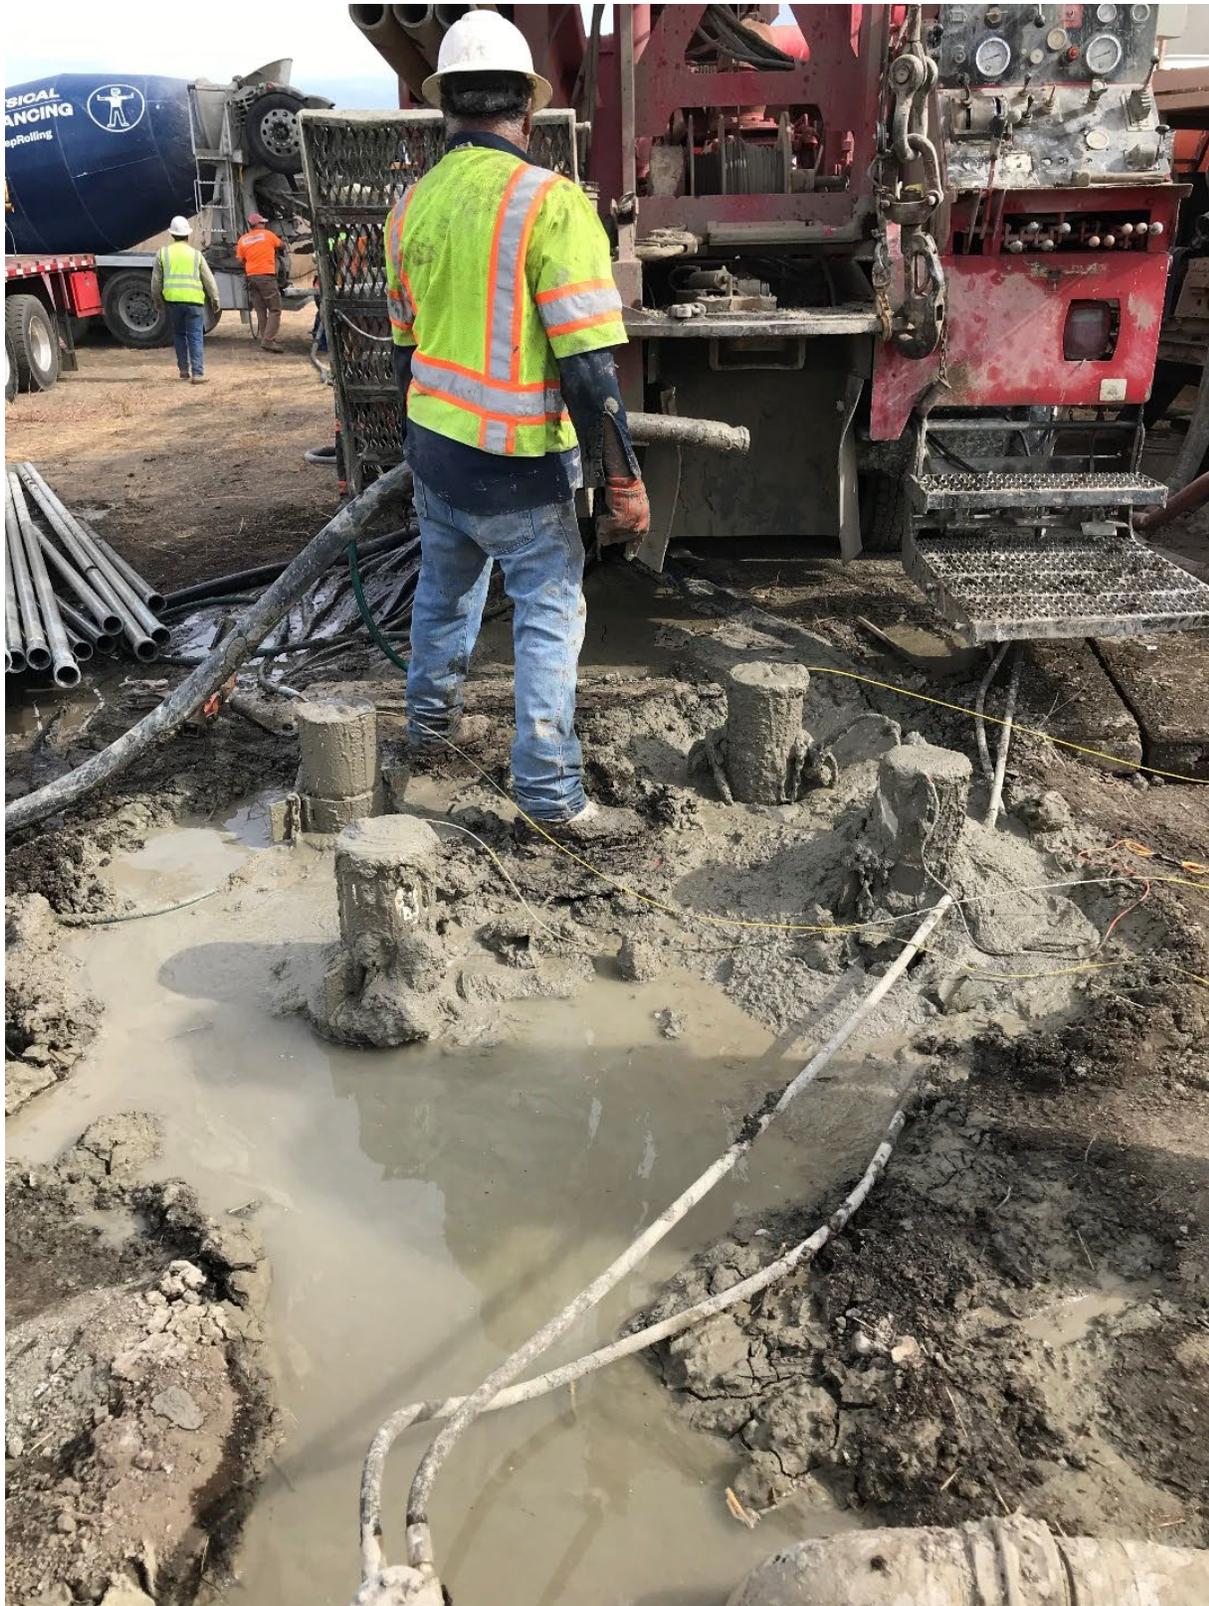
Photograph 97: View of barrier wells following detonation at Well D005 site.
Final Project Report, Old Jarvis Road Irrigation Well Destruction Project
Photographed by Pablo Cortez
