FINAL PROJECT REPORT

Grantee: Alameda County Water District
Title: Old Jarvis Road Irrigation Well Destruction Project
Agreement No.: D1712501
Date: March 30, 2022
Project Type: Groundwater Implementation
Total Project Cost: \$413,931.00

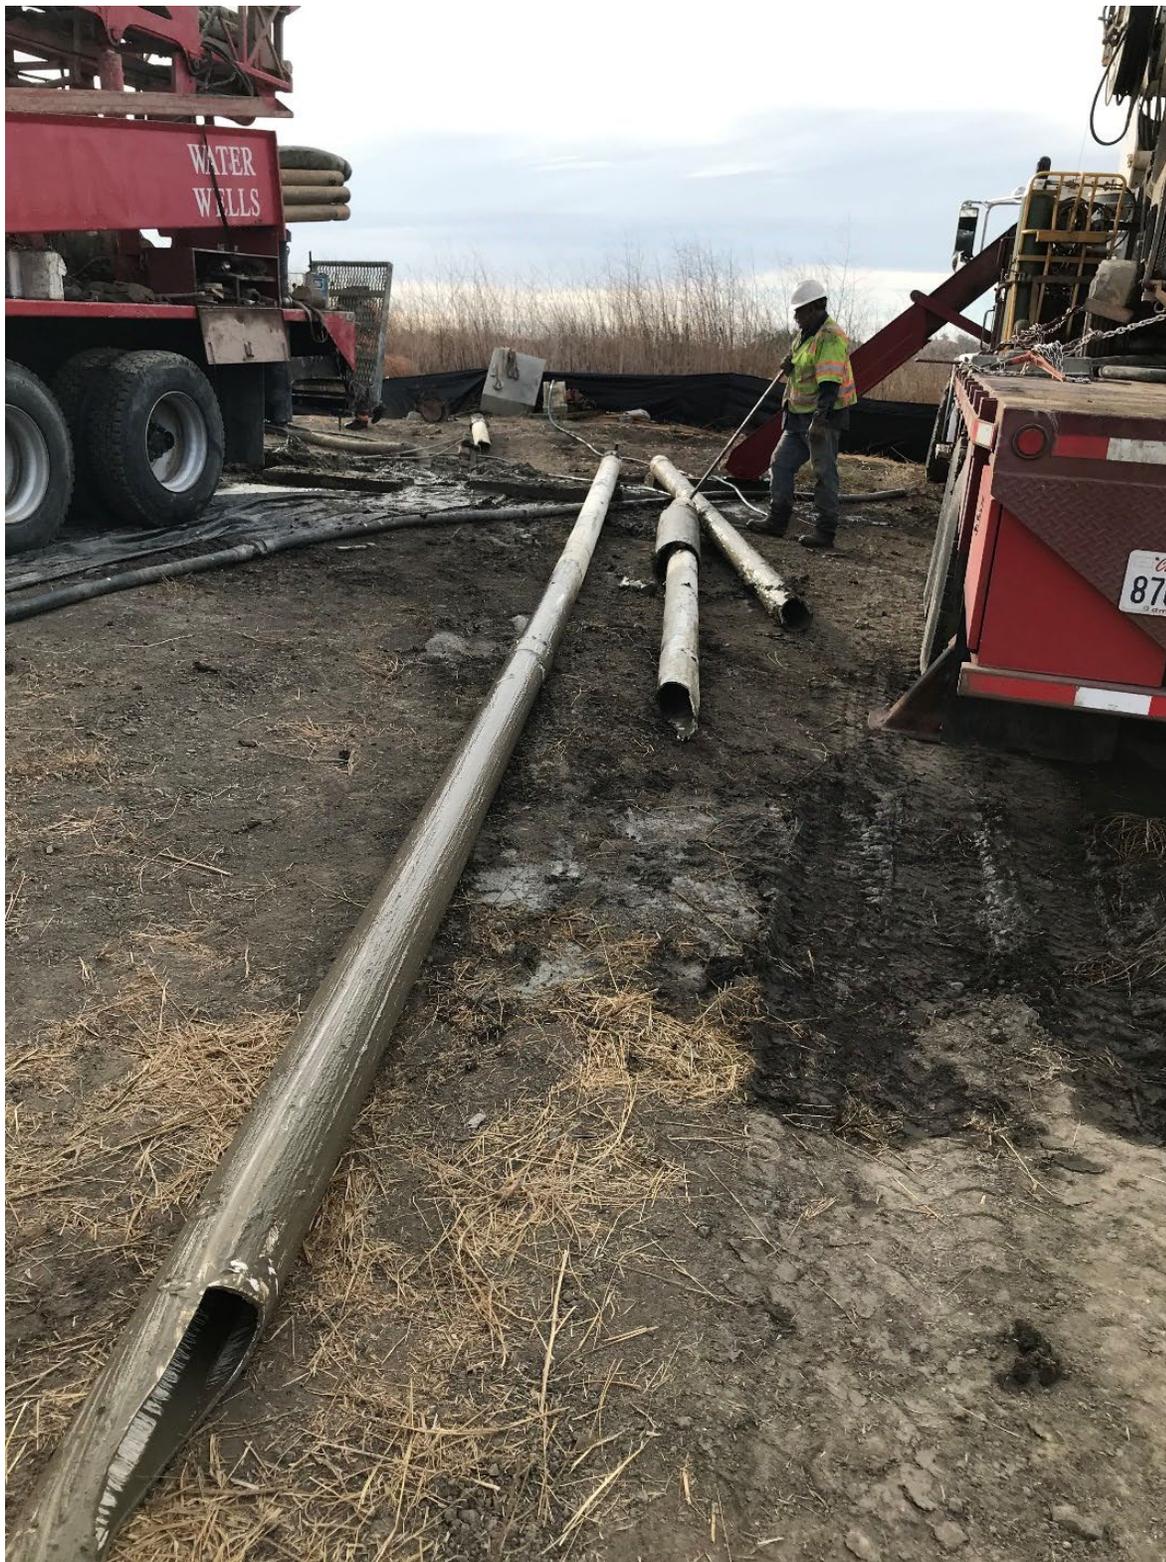
Photograph 98: View of casings following destruction of Well D005.

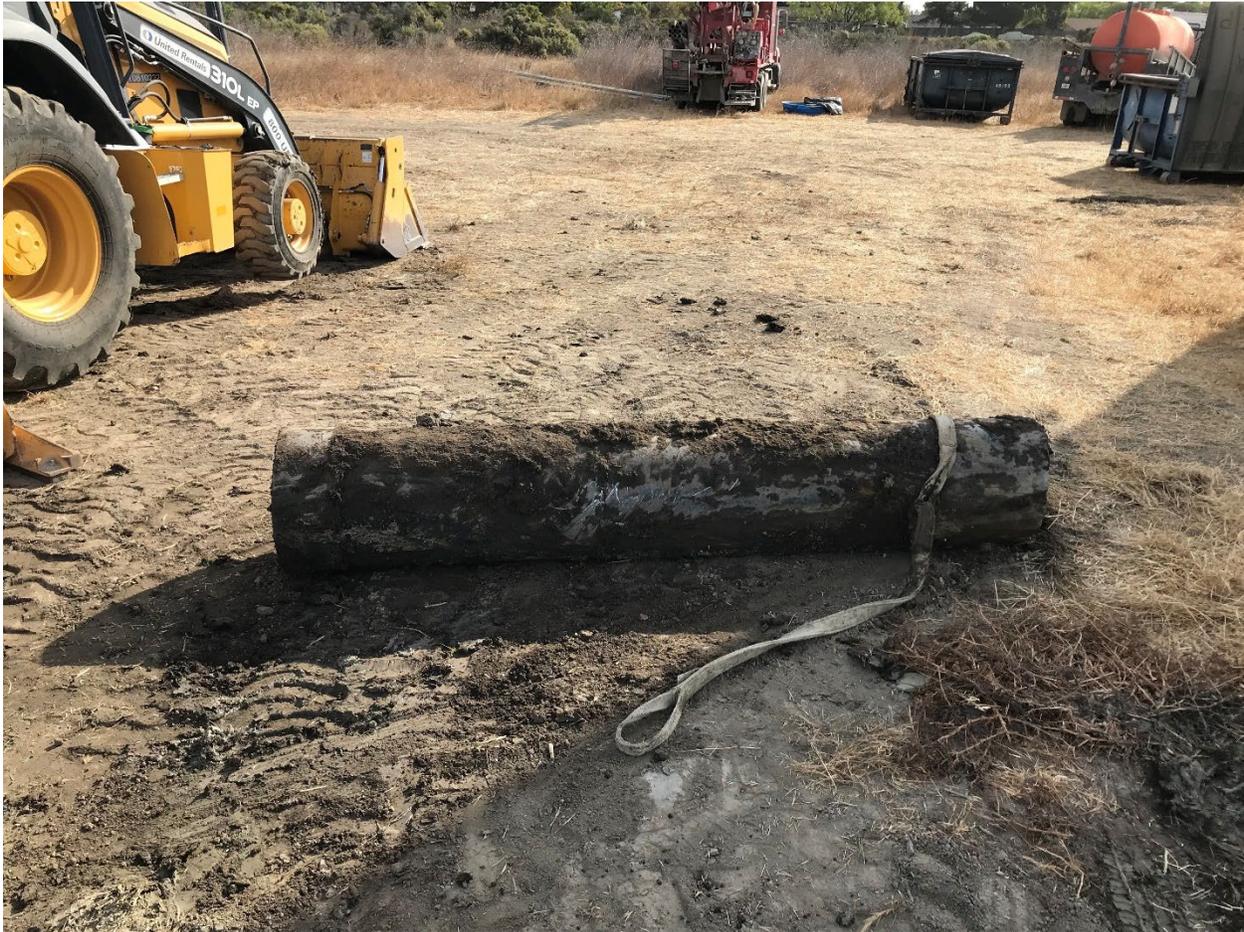
Photograph 99: Top five feet of casing removed from Well D005.

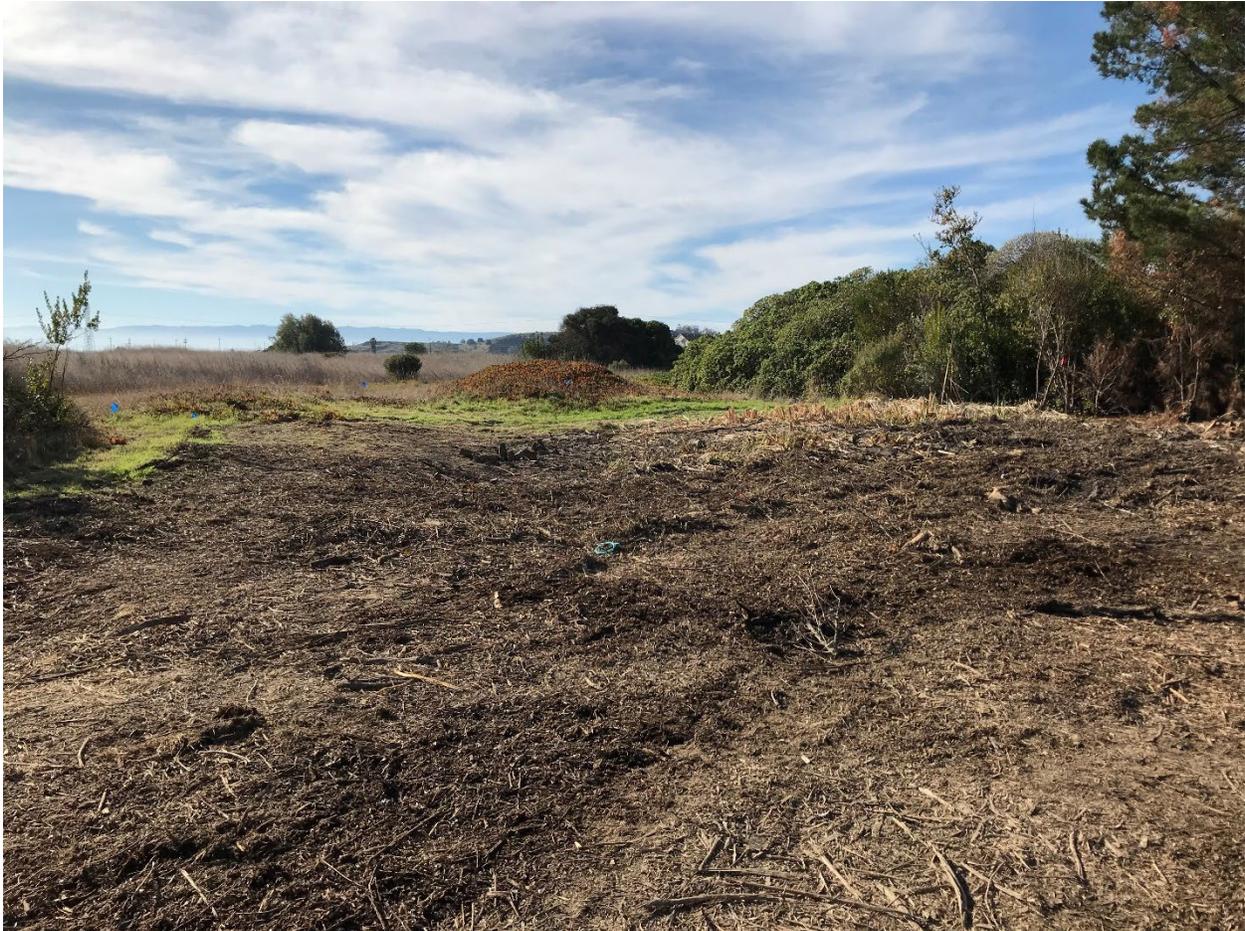
Photograph 101: View of Well D001 site following site restoration.

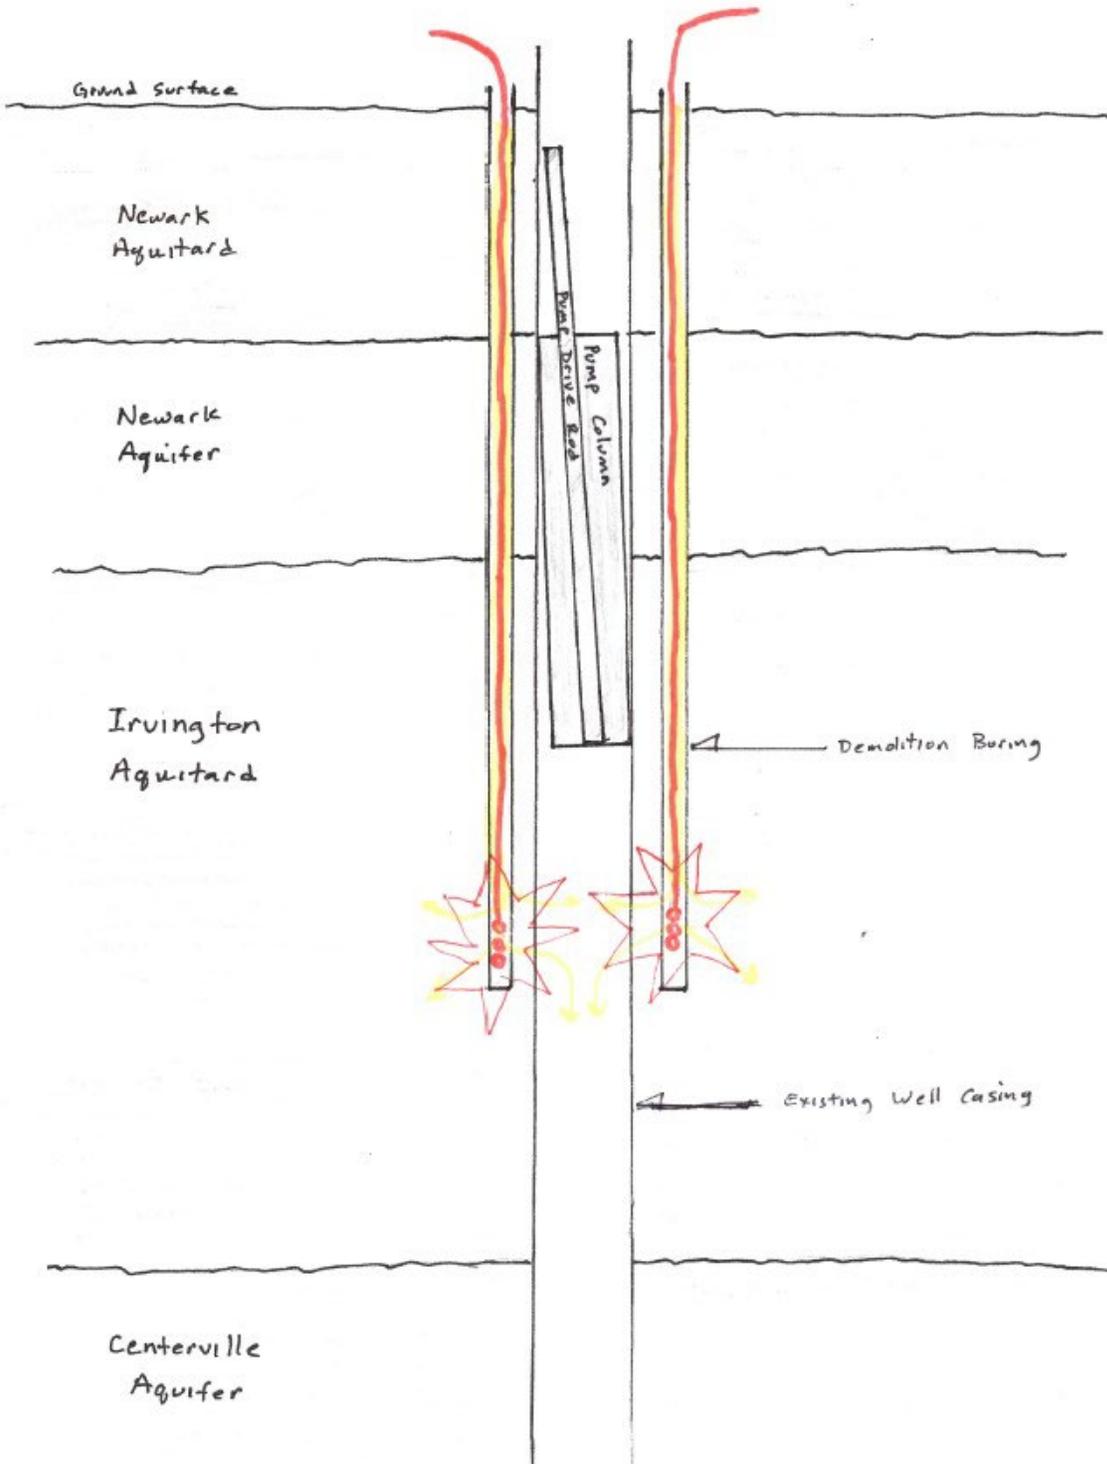
The detonation cord for all wells was placed to 120 feet bgs with four boosters placed from 80 to 120 feet bgs and an additional charge placed at 20 feet bgs to sever the PVC casings on the barrier wells. The four barrier wells were tremie grouted with neat cement to surface through the 2-inch steel tremie pipes. On October 6, 2021, the four barrier wells were perforated using explosive charges at specific intervals of the Well, including at 20 feet bgs (with extra booster) and every 10 feet from 80 feet bgs to 120 feet bgs, hence completing destruction of Well D005. The remaining barrier well PVC casings were removed, the borings were completed to surface with neat cement, and control casings were removed.

Figure 1. Conceptual Drawing for Alternate Destruction Approach for Well D005
