2023-2024 Annual Report for the Alameda Creek Fish Ladder Operations and Water Stewardship (FLOWS) Monitoring Program

Alameda County Water District
Alameda County Flood Control and Water Conservation District

April 15, 2025

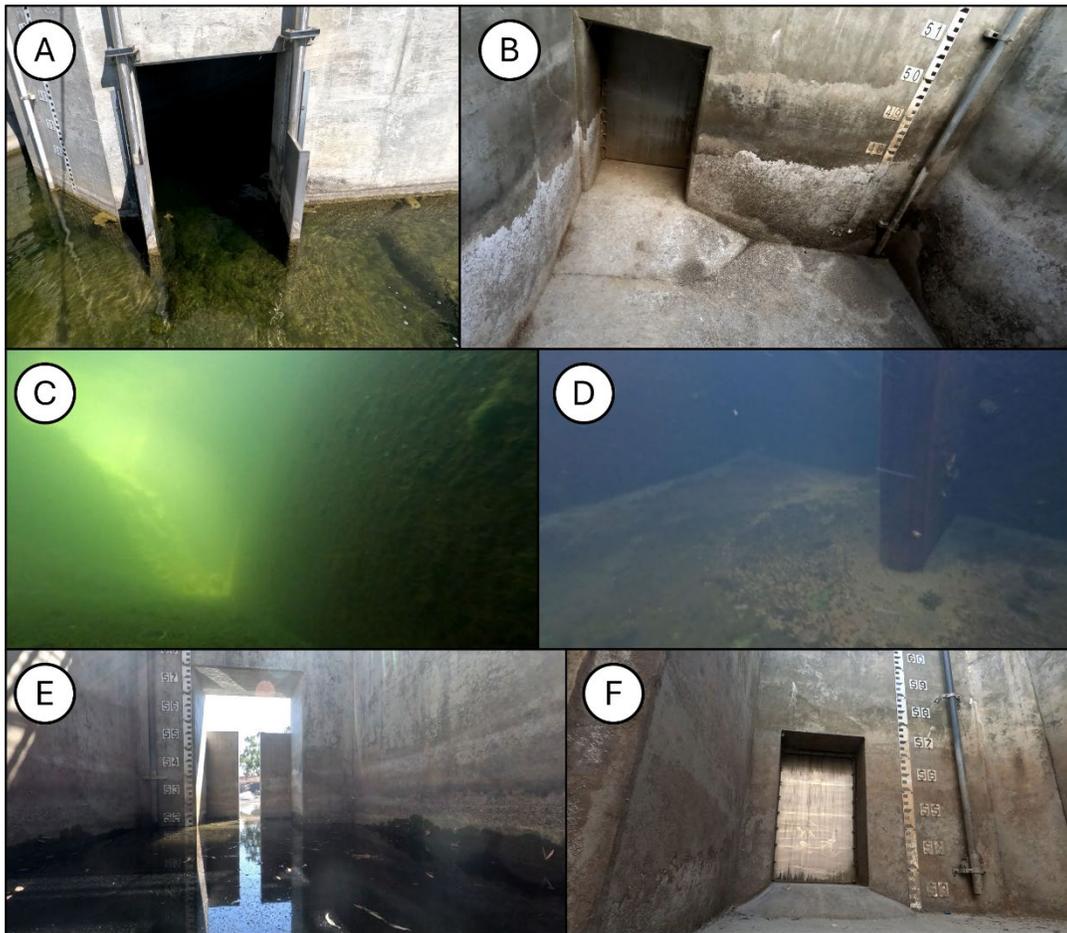
Figure 2.1: Video survey images of A) the RD1 vertical slot fish ladder entrance (downstream) gates, B) RD1 vertical slot fish ladder exit gate 3 (downstream face/inside ladder face) and interior of pool 16, C) RD1 vertical slot fish ladder pool 1 looking downstream to entrance gates, D) RD1 vertical slot fish ladder pool 5, E) RD3 fish passage facility entrance gates (interior view looking downstream), F) RD3 fish passage facility exit gate 1 (interior view, looking upstream).

ACWD Water Supply conducted a video survey using a GoPro camera mounted on an extension pole for observing conditions within the RD3 and RD1 vertical slot fish ladders. The survey did not identify any structural flaws, plant or algal growth, obstructions, sharp edges, or significant sediment deposits. The lack of observed obstructions or flaws suggests fish passage was unimpeded in the ladders. Figure 2.1(A)-(E) below are representative of conditions observed during the video survey.

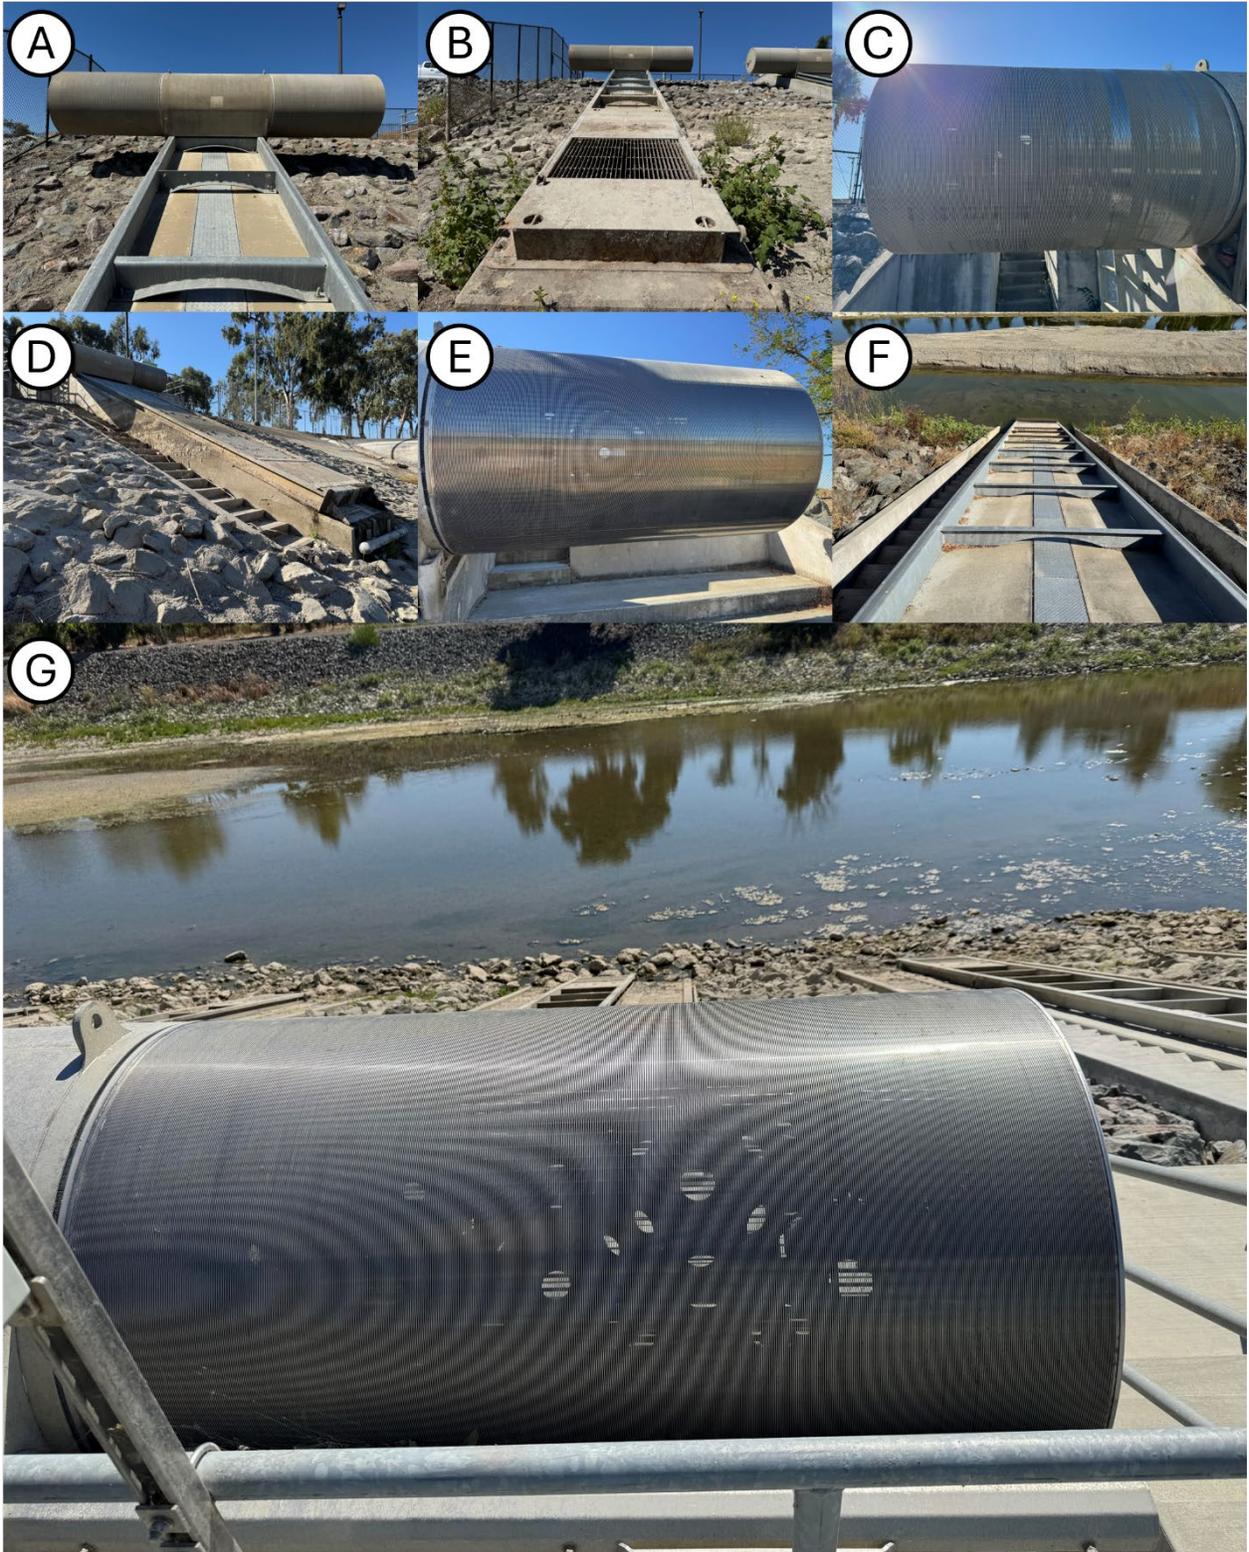
Figure 2.2: Images taken during the fish screen inspections. Featured are the A) Mission facility fish screen, B) Mission facility fish screen track, C) Bunting facility fish screen, D) Bunting facility fish screen track, E) Kaiser facility fish screen track, F) Kaiser facility fish screen track, G) Shinn fish screen facility showing one screen and three tracks.

In addition to the daily inspections of the screened diversions, ACWD Water Supply staff conducted an annual inspection of all fish screens and diversions to document their conditions. These inspections included noting the conditions of the channel around the screens, screen track, diversion structure, protective plates, grating, slide gates, control systems, screen faces, and screen cleaning systems. Staff noted if there were any signs of impairment due to sediment, debris, algal growth, or if there were other conditions that could compromise functionality. The screens were inspected to confirm they were firmly attached and had no gaps, holes, rips or tears. Facility components were inspected for any loose, broken, or missing components, or for sharp edges. All facilities appeared to be satisfactory, and no subsequent repair work was identified due to the inspections. The following images in Figure 2.2(A)-(G) are representative of conditions observed during the inspections.

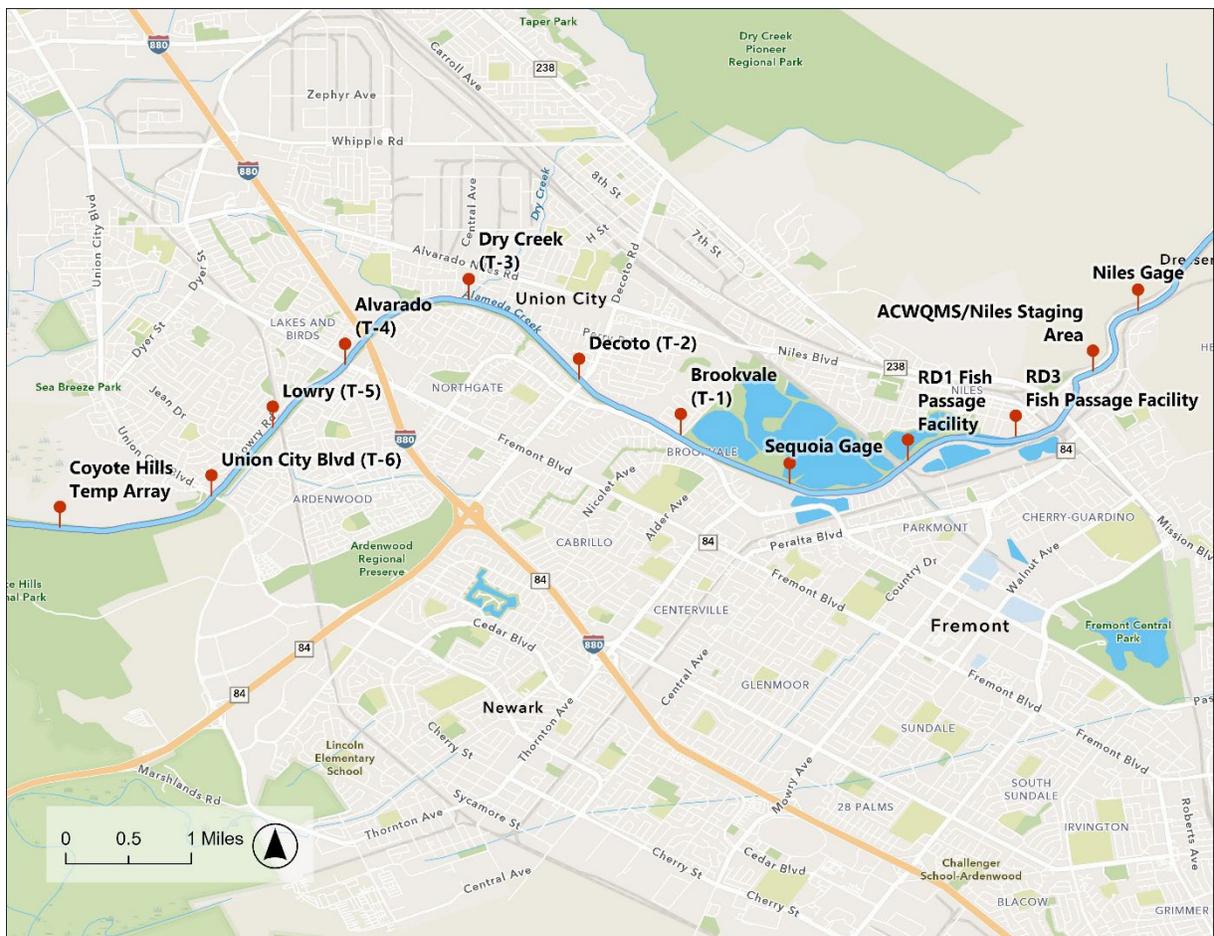
Figure 2.3: Map of dissolved oxygen and temperature sensors, USGS gages, and monitoring. Beginning upstream, there is the Niles Gage which monitors parameters such as DO and temperature. Turbidity samples are collected at the Alameda Creek Water Quality Monitoring Station (ACWQMS) at the Niles Staging Area. At the RD3 fish passage facility, there is one temperature sensor at the exit gate and dissolved oxygen sensor at the RD3 forebay. Within the RD1 vertical slot fish ladder, one sensor is near the entrance gate at the downstream end of the vertical slots, and another upstream at the exit channel of the fish ladder; there is a single DO logger located in the impoundment (approximately mid-water column) near the trash rack of the fish ladder and a DO and temperature array in the middle of the RD1 impoundment. The Sequoia Gage monitors parameters such as DO and temperature. The remaining temperature sensors (T 1-6) are located downstream of the RD1 and BART Weir fish passage facility along the Alameda Creek Flood Control Channel down to a temperature array at the Coyote Hills Estuary.

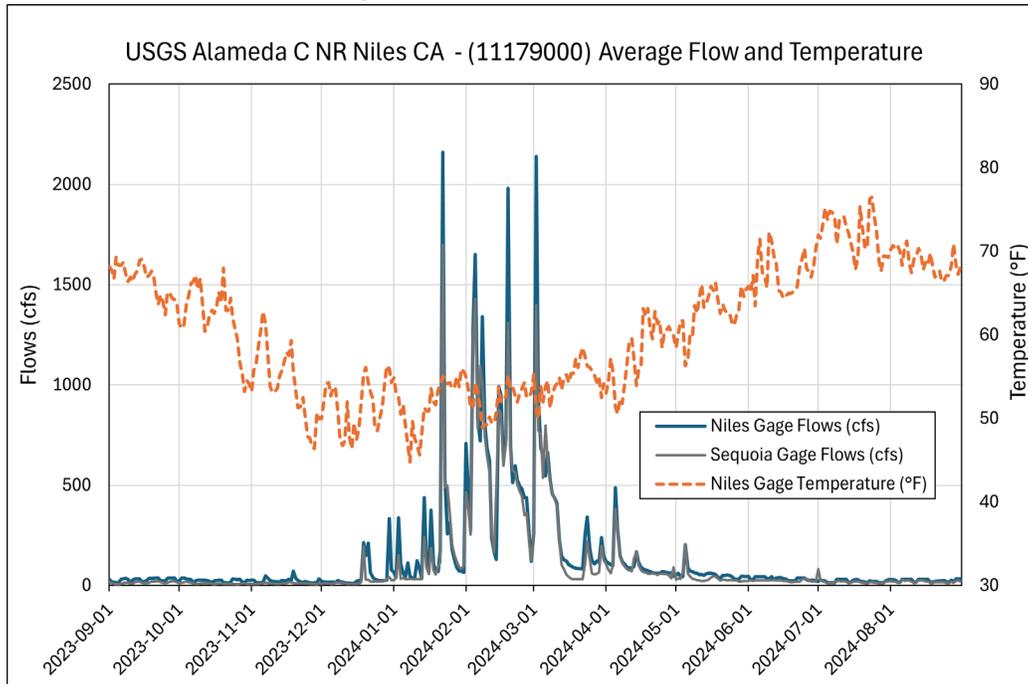
Figure 2.4: Average flows (cfs) at the Niles and Sequoia gages and average surface water temperature (F) at the Niles gage from 1 September 2023 through 31 August 2024.

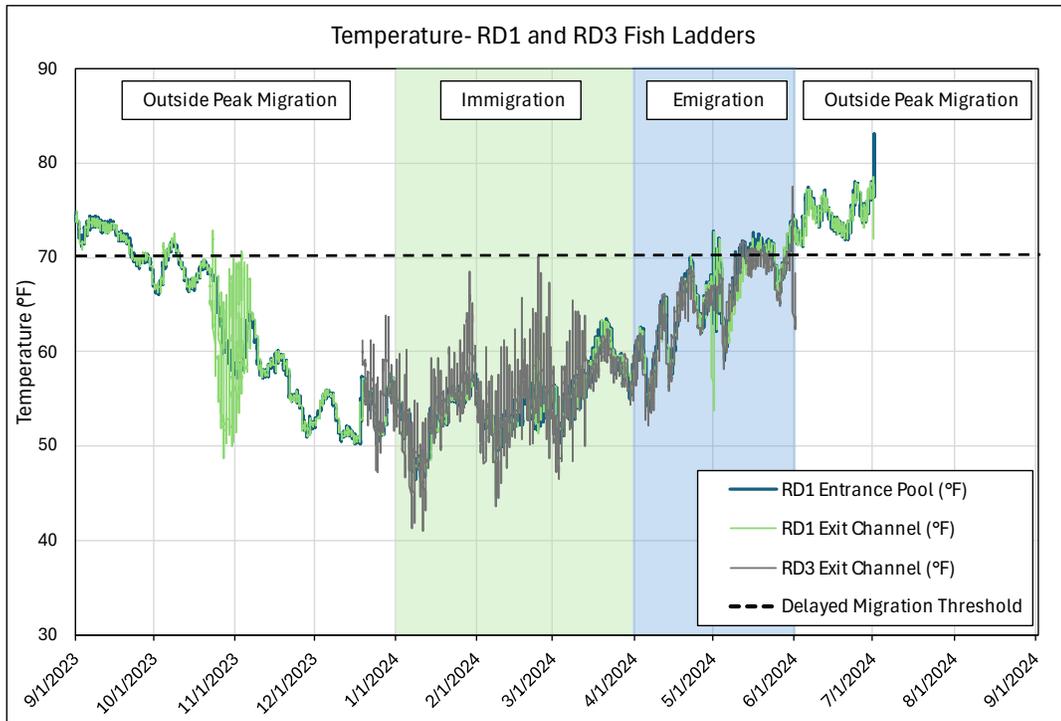
Figure 2.5: Temperature as measured at the upstream exit channel of the RD1 fish ladder (green), downstream entrance pool (blue), and at the upstream exit gate of the RD3 fish ladder (grey). No data was collected from at the RD3 exit channel from 1 September 2023 - 18 December 2023, due to RD3 rupturing in January 2023. RD3 was deflated in June 2024 and the RD1 fish ladder started to be dewatered beginning July 2024, affecting passage and affecting temperature readings within the fish ladder due to low flows. Refer to Section 4.5 for more detail regarding the water quality data in June and July 2024.

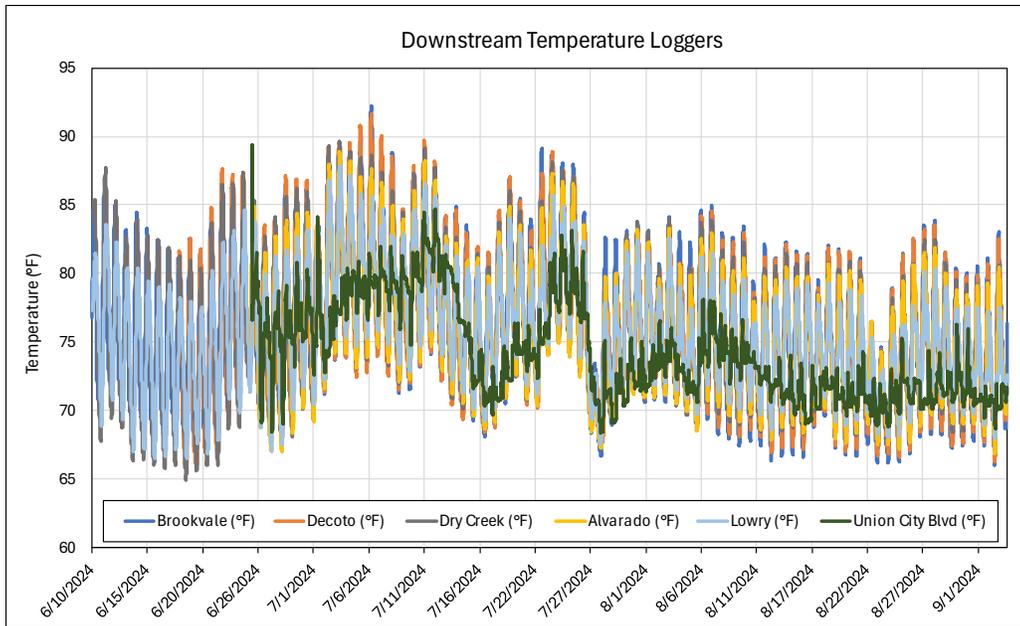
Figure 2.6: Temperature variations recorded by loggers at six downstream locations of RD1 (Figure 2.3; T 1-6) from 10 June through 31 August. The data indicates diurnal fluctuations in temperature with downstream sensors (Lowry and Union City Blvd) recording lower temperatures compared to upstream loggers. This reflects influence on temperature when moving downstream in the Alameda Creek Flood Control Channel and closer to San Francisco Bay.

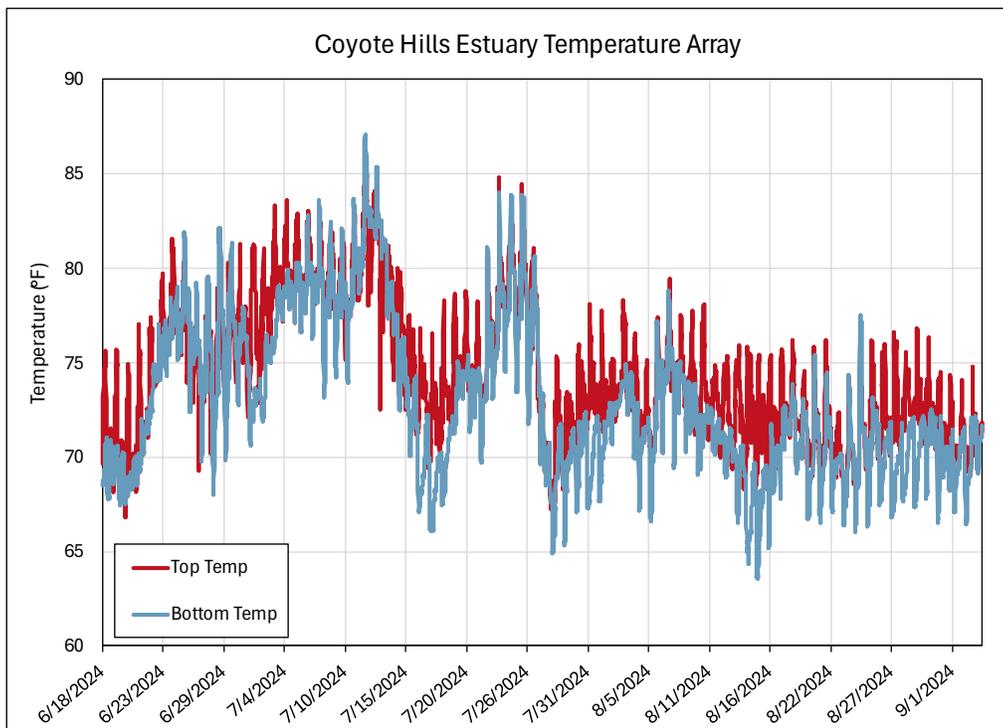
Figure 2.7: Water temperature at the Coyote Hills Estuary from 18 June through 31 August recorded at two different depths: surface (red) and bottom (blue). The data shows diurnal fluctuations with surface temperatures recording slightly higher values than temperatures near the bottom of the Alameda Creek Flood Control Channel.

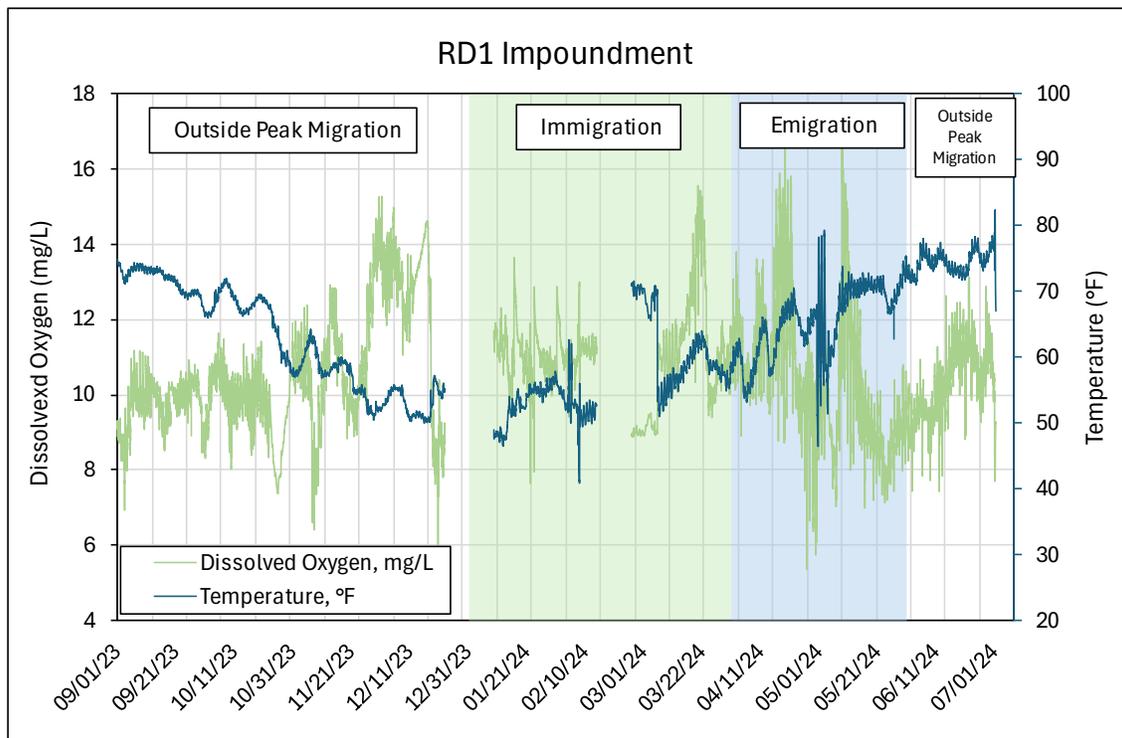
Figure 2.8: DO and temperature levels recorded at the RD1 impoundment near the RD1 trash racks from 1 September 2023 to 2 July 2024. DO sensor was removed while RD1 was deflated from 23 December 2023 to 21 January 2024, 15 February 2024 - 26 February 2024, and 2 July 2024 - 31 August 2024. DO levels remained around a range of 8-14 mg/L and temperature around 50-80°F during the 2023-2024 reporting period.

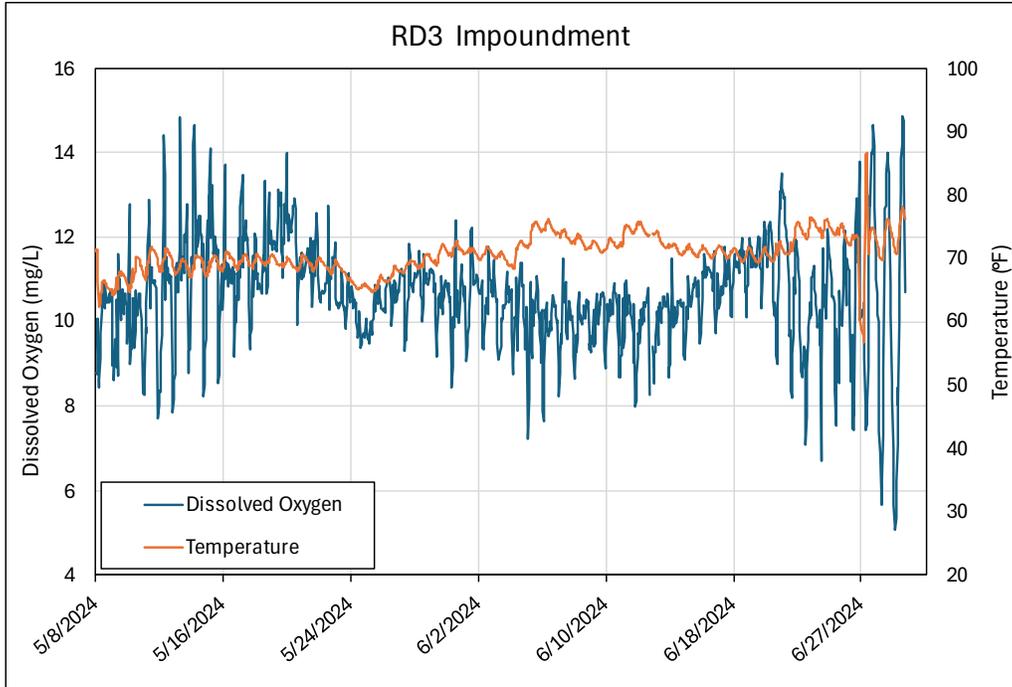
Figure 2.9: DO and temperature levels recorded at the RD3 forebay from 8 May 2024 to 30 June 2024. The DO sensor was removed on 30 June 2024 to avoid damages while RD3 was deflated for maintenance. From May to June, DO levels at the RD3 forebay ranged from about 8-12 mg/L and temperature ranged from about 65-70°F.

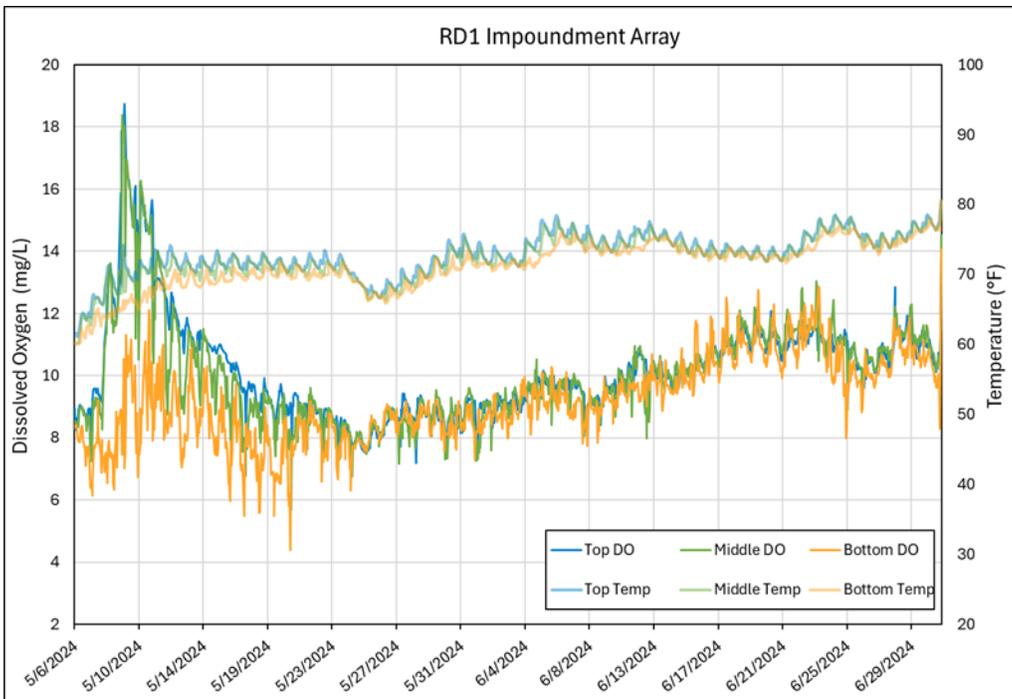
Figure 2.10: DO concentrations (mg/L) and temperature (°F) trends at three different depths within the RD1 impoundment from 6 May 2024 to 1 July 2024. DO concentrations exhibit an initial spike followed by a gradual decline, stabilizing around mid-May. Temperature trends show a steady increase with higher temperatures observed in late June.

To assess reservoir conditions, ACWD deployed a DO and temperature array to gain a depth profile of the RD1 impoundment. The array consisted of three HOBO U26 DO loggers, a buoy to keep it afloat, a concrete brick to hold it in place on the bottom of the creek, and a 13 ft long stainless-steel chain connecting it all together. The DO sensors were placed equidistant from each other to record DO and temperature data at three different depths: near the surface, middle, and near the bottom of Alameda Creek. Refer to Figure 2.10 for a summary of results of the DO array.

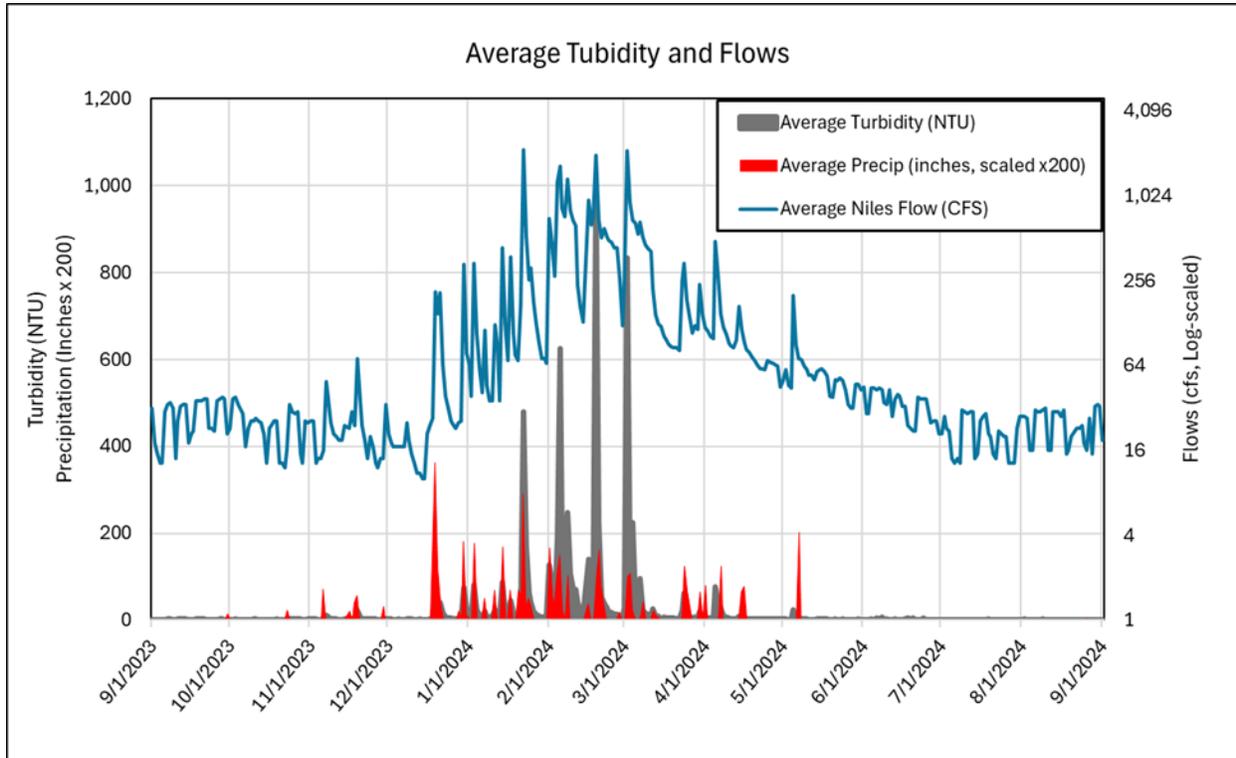
Figure 2.11: Daily average turbidity (NTU) and flows (cfs) at the Niles Gage (Figure 1) from 1 September 2023, through 31 August 2024. Turbidity sampled daily at the upstream monitoring station in Alameda Creek.

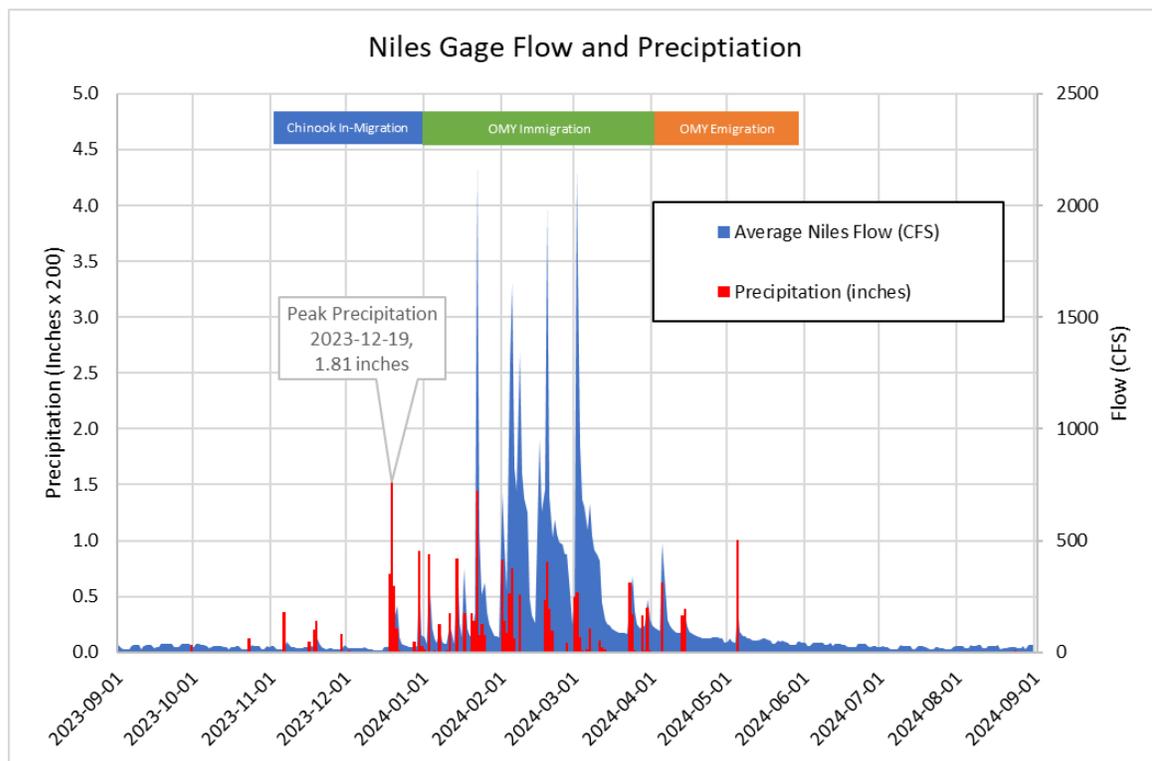
Figure 3.2: Estimated daily precipitation (inches; red bars) plotted against the Niles gage (cfs; blue region) from 1 September 2023 through 31 August 2024. Salmonid migration timing is plotted across the top in blue (Chinook salmon adult immigration), green (*O. mykiss* adult immigration), and orange (*O. mykiss* adult emigration). Y-axes are scaled to match the dataset. OMY = *O. mykiss*.

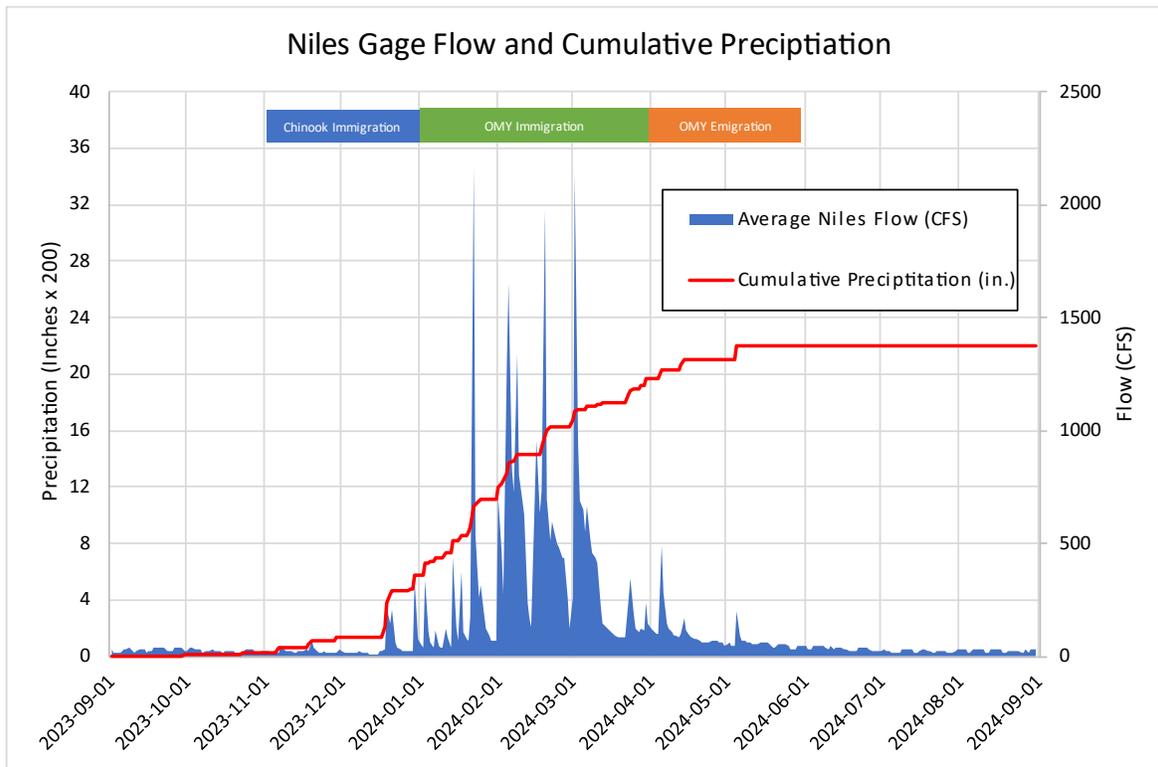
Figure 3.3: Cumulative Precipitation (inches) vs Flow recorded at the Niles gage (cfs). 1 September 2023 through 31 August 2024. Salmonid migration timing is plotted across the top in blue (Chinook salmon adult immigration), green (*O. mykiss* adult immigration), and orange (*O. mykiss* adult emigration). Y-axes are scaled to match the dataset. OMY = *O. mykiss*.

Daily precipitation accumulation demonstrated the 15.3-inch threshold for normal/wet operations was reached in February 2024 (Figure 3.3). Based on the year determination criteria per the BiOp, this was a normal/wet year. Per the BiOp, for a normal/wet year, the minimum bypass flow at the ACFCD flood control drop structure for *O. mykiss* emigration (from April 1-May 31) requires 12 cfs plus net SFPUC releases that arrive at the Niles gage for all daily average inflow volumes measured at the Niles gage. The normal/wet determination also eliminated the need to prepare for pulse releases in accordance with the 7-Day Pulse Framework¹.

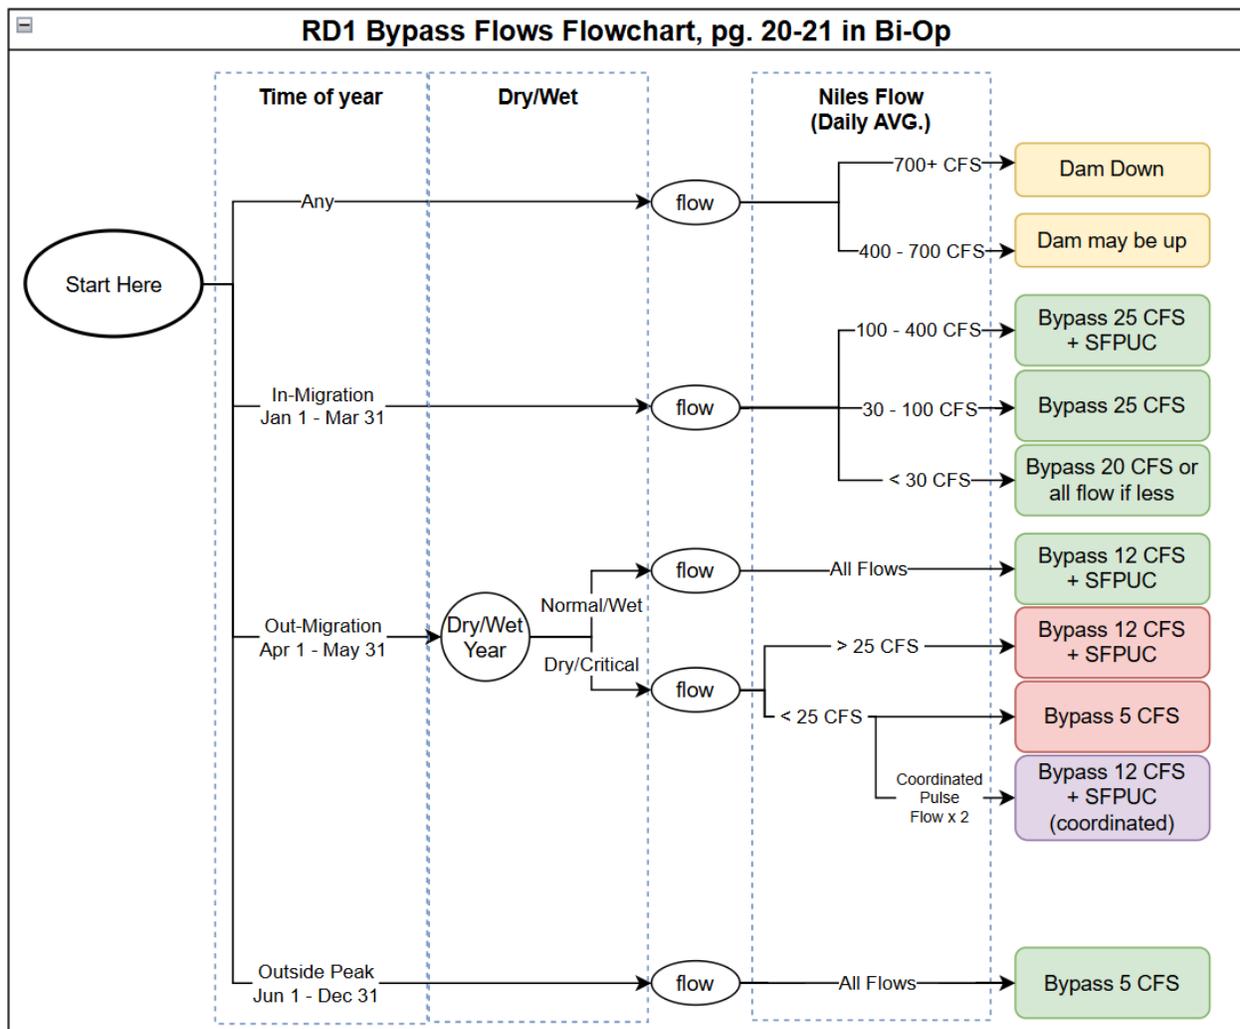
Figure 3.4: Flows chart of bypass requirements, depending on time-of-year, Niles inflows, and wet or dry/critical dry conditions.

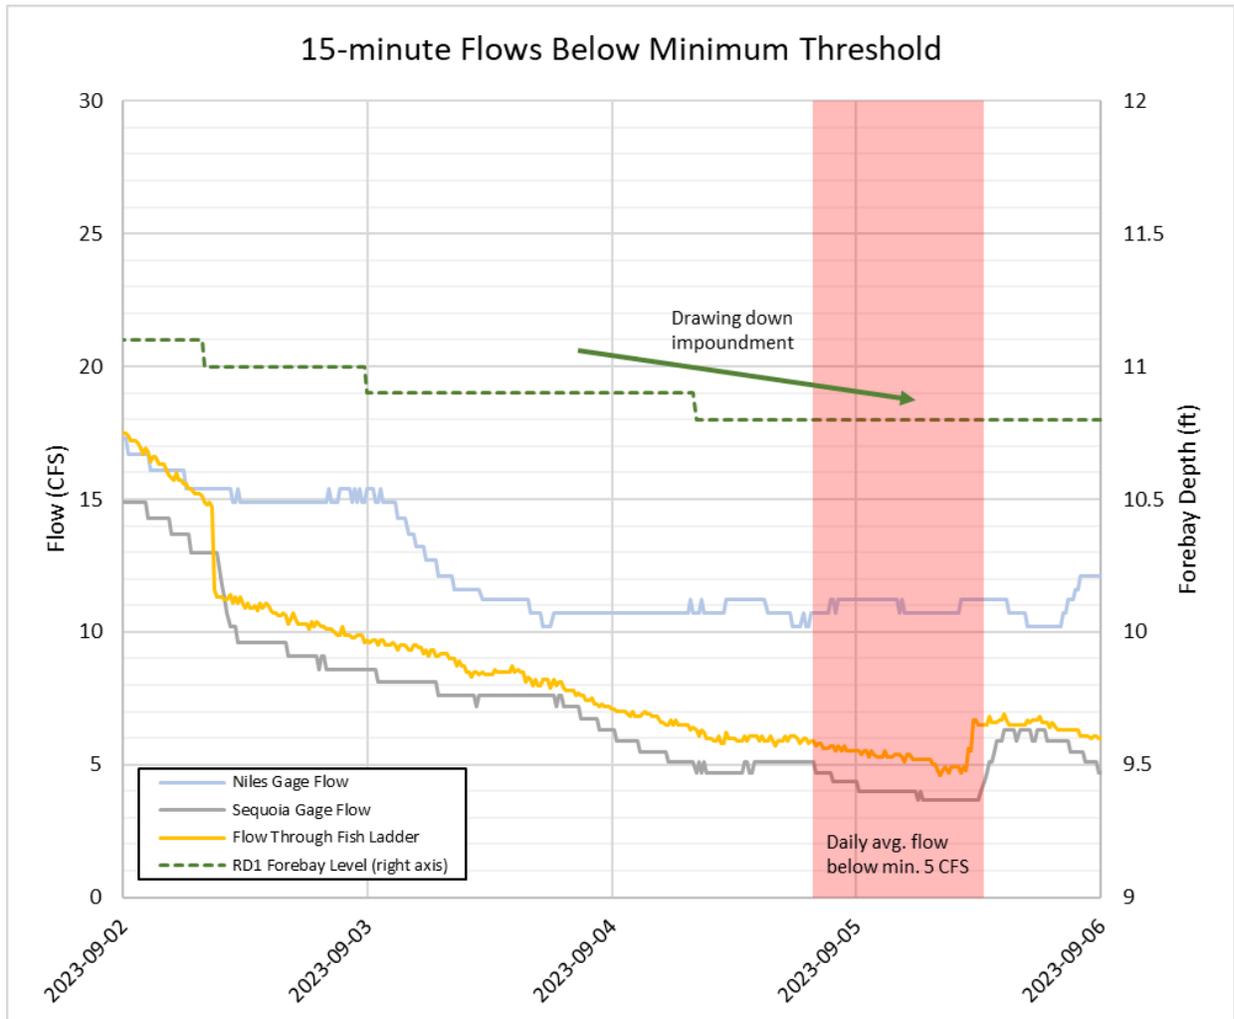
Figure 3.5: Granular Analysis. Highlighting the one day in which summer bypass flows were below the target flow of 5 cfs due to prevailing low flows at the USGS Alameda C NR Fremont CA - (11179000). Note that during this time the RD1 impoundment was dropping, and therefore no additions to storage were made at this time.

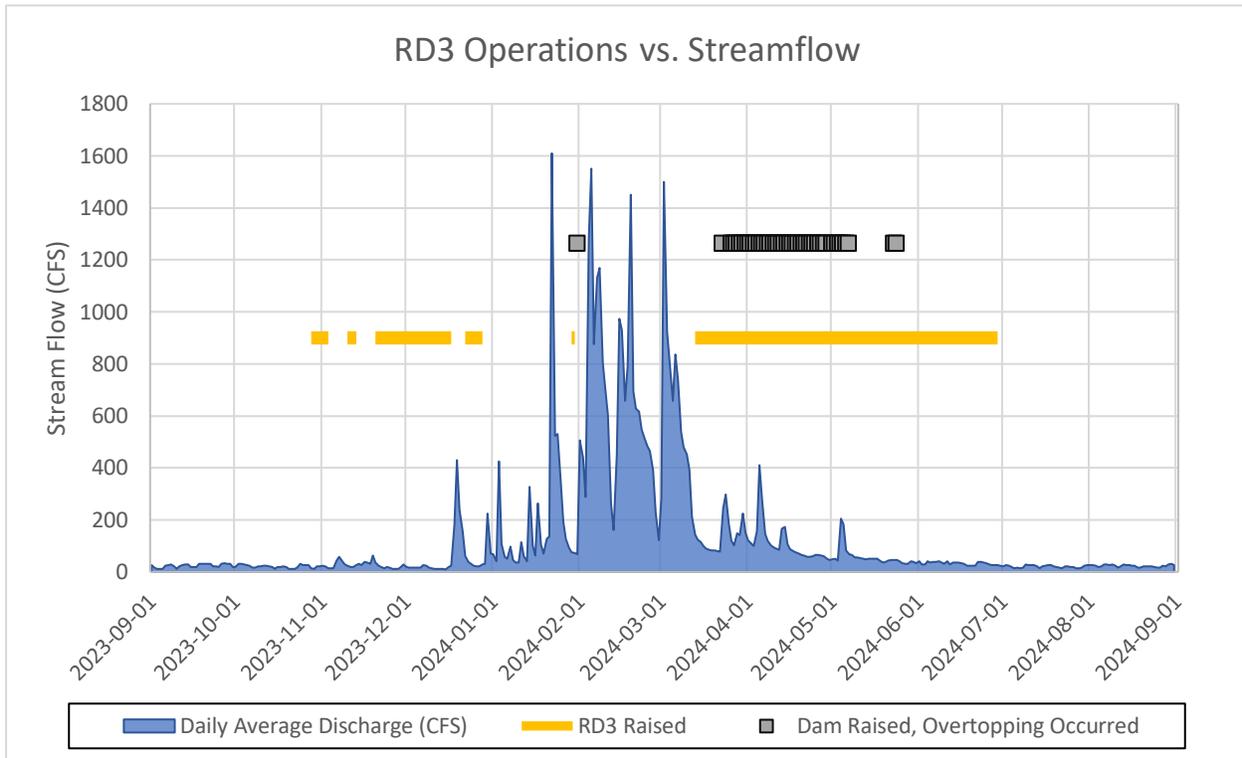
Figure 3.6: Stream flows measured at Niles gage. Graph shows periods where RD3 was inflated, and where RD3 overtopped while inflated.

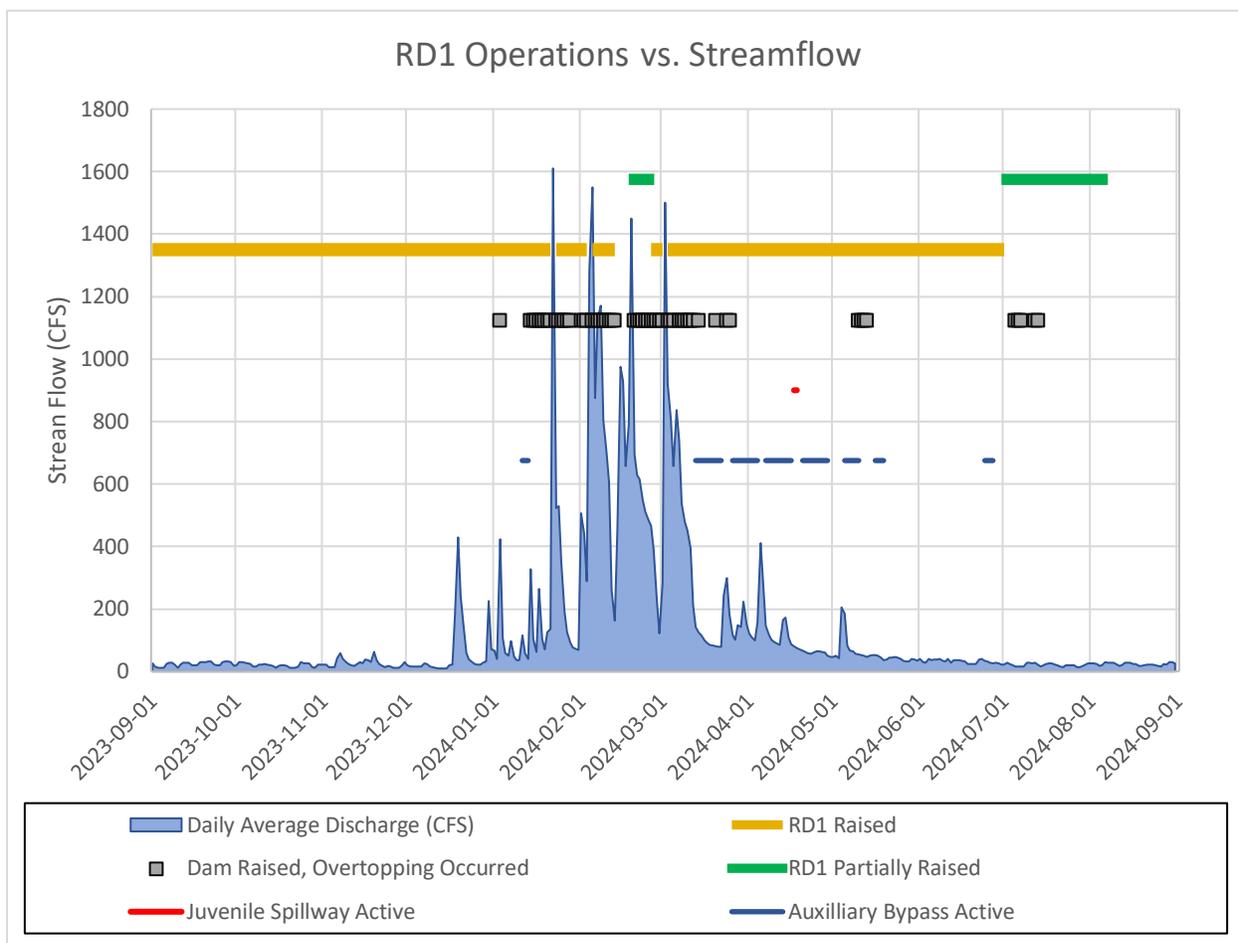
Figure 3.7: Stream flows measured at Niles gage. Graph shows periods where RD1 was fully inflated, partially inflated, where overtopping occurred while fully or partially inflated, and where the auxiliary and juvenile systems were active.

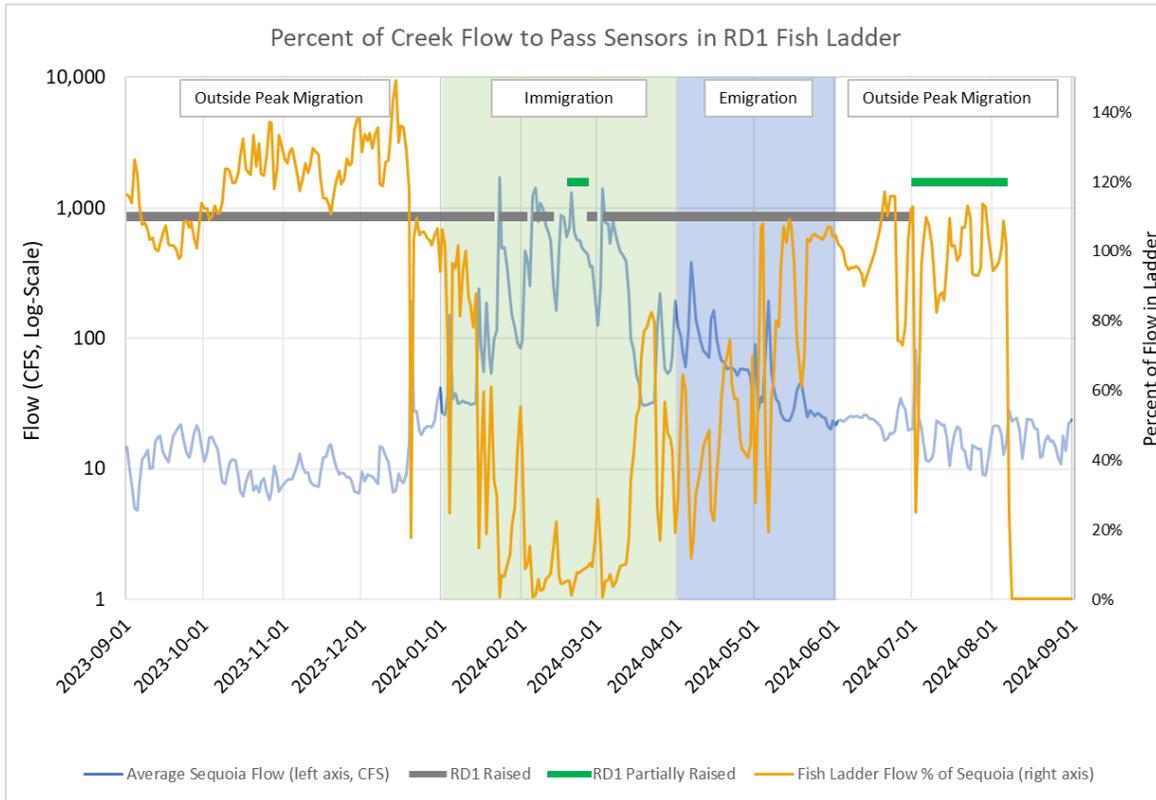
Figure 3.8: Fish ladder flow as a percentage of channel total as measured at Sequoia Gage, 1 September 2023 through 31 August 2024.

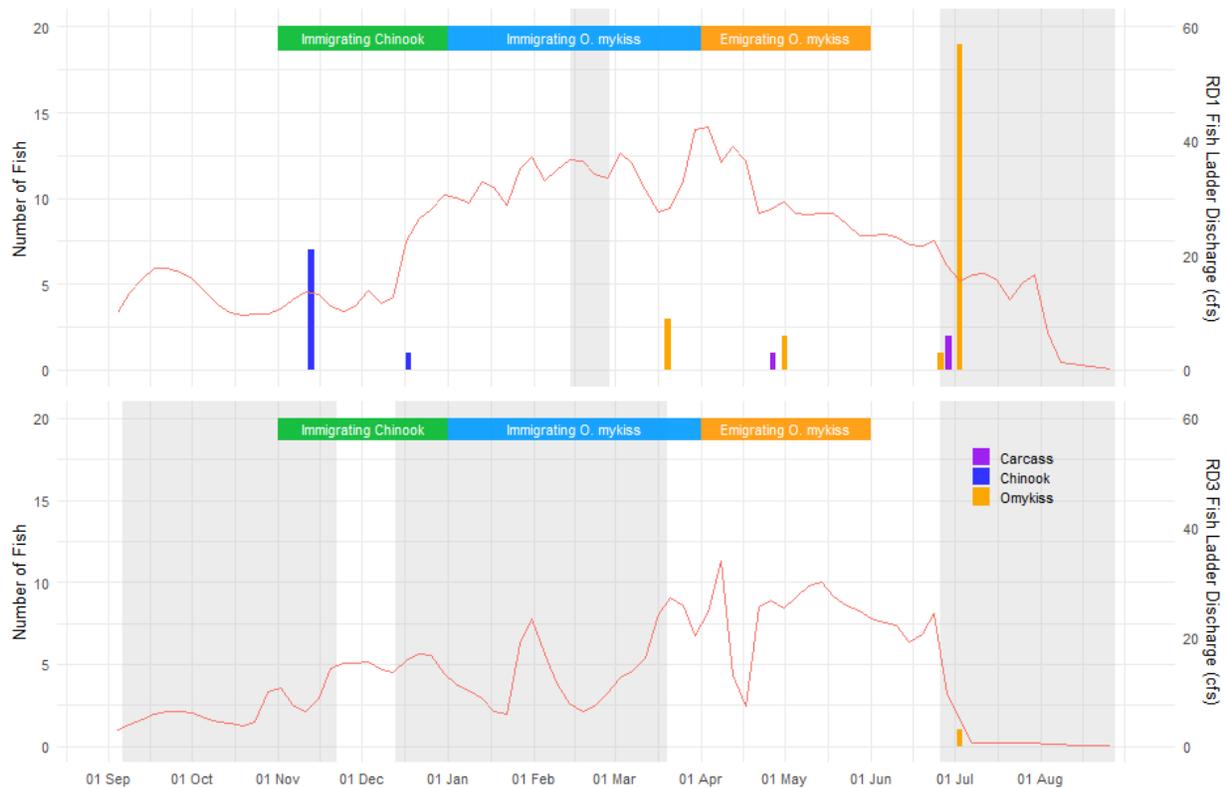
Figure 4.1: Number of target species visually observed at the RD1 and BART Weir (top) and RD3 (bottom) fish passage facilities. Gray areas indicate weeks where dams were deflated. Discharge in each fish ladder was calculated as the mean weekly value recorded by ACWD. Though not highlighted here, juvenile Chinook Salmon are expected to be emigrating through the Alameda Creek Flood Control Channel from February through May. Migration timing for immigrating and emigrating Chinook Salmon and *O. mykiss* are assumed from the Project's BiOp (NMFS 2017) and the literature (e.g., Moyle 2002).

Target species observed included *O. mykiss* and Chinook Salmon (Figure 4.1). Most *O. mykiss* observations occurred in early July when the RD1 impoundment was lowered for routine maintenance scheduled for summer 2024. A total of three *O. mykiss* carcasses were observed and collected downstream of the RD1 fish ladder following stranding events throughout the migration period (see Section 4.2 for details). NMFS and CDFW were notified by ACWD immediately following all *O. mykiss* stranding events and carcass recoveries. Three *O. mykiss* estimated to be around 100 to 200 mm in length were observed by ACWD and WRA staff in the plunge pool downstream of RD1 on 22 March after it had become isolated, while two other live *O. mykiss* were observed by ACWD and WRA staff at the upstream exit of the RD1 fish ladder on 2 May. An observation of several adult Chinook Salmon was recorded near the RD1 fish ladder on 19 November; however, photos of these fish were not collected so their identification could not be confirmed. One additional Chinook Salmon observation was made in the RD1 fish ladder on 18 December when it was dewatered.

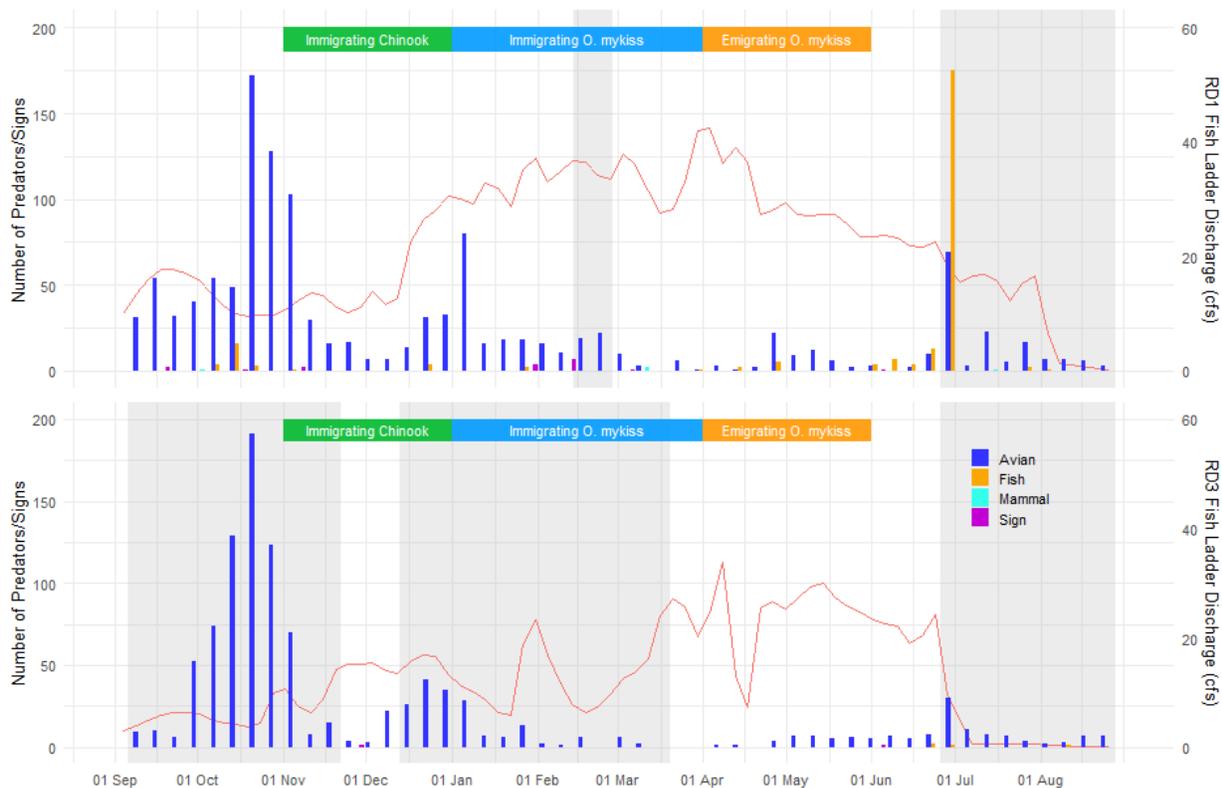
Figure 4.2: Number of potential predators visually observed at the RD1 and BART Weir (top) and RD3 (bottom) fish passage facilities. Gray areas indicate weeks where dams were deflated. Discharge in each fish ladder was calculated as the mean weekly value recorded by ACWD. Though not highlighted here, juvenile Chinook Salmon are expected to be emigrating through the Alameda Creek Flood Control Channel from February through May. Migration timing for immigrating and emigrating Chinook Salmon and *O. mykiss* are assumed from the Project's BiOp (NMFS 2017) and the literature (Moyle 2002).

Potential predators observed at the RD1 and BART Weir and RD3 fish passage facilities from 1 September 2023 to 31 August 2024 included avian, fish, and mammal species (Table 4.2; Figure 4.2). Potential avian predators were observed consistently throughout the monitoring period, with the majority occurring in October and November before the assumed *O. mykiss* migration period (1 January - 31 May). The most common potential avian species included merganser (*Mergus* spp), cormorants (*Nannopterum* spp), Great Egret (*Ardea alba*), Snowy Egret (*Egretta thula*), and Brown Pelican (*Pelecanus occidentalis*). Potential fish predators included black bass (*Micropterus* spp) and Sacramento Pikeminnow (*Ptychocheilus grandis*). Most of the predatory fish were observed in early July when the RD1 impoundment was lowered for routine maintenance scheduled for summer 2024. Potential mammalian predators included North American River Otter (*Lontra canadensis*) and Coyote (*Canis latrans*). Though not included in counts of potential predator observations, turtles, Turkey Vultures (*Cathartes aura*), and avians of unknown species were also observed at the facilities. There were also 23 and 5 signs of predators observed at the RD1 and BART Weir and RD3 fish passage facilities, respectively.
