2023-2024 Annual Report for the Alameda Creek Fish Ladder Operations and Water Stewardship (FLOWS) Monitoring Program

Alameda County Water District
Alameda County Flood Control and Water Conservation District

April 15, 2025

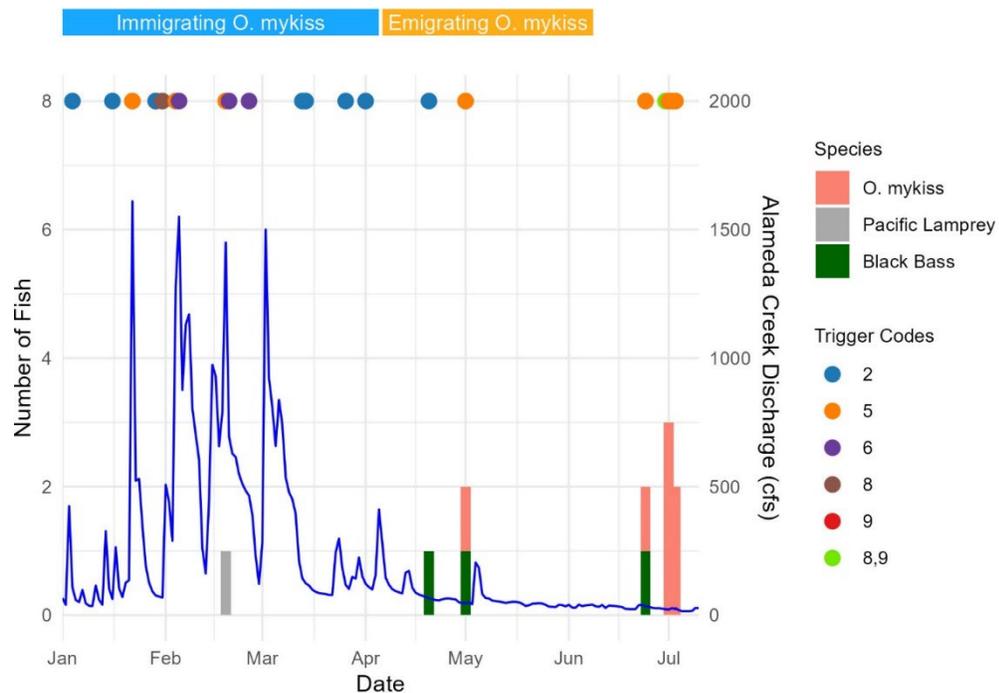
Figure 4.3: Stranding survey results from 1 January through 10 July 2024. Alameda Creek flows measured at the USGS Alameda C NR Fremont CA (11179100) stream gage. Daily counts of species are stacked.

There were 21 stranding surveys completed at the RD1 and RD3 fish passage facilities between 4 January and 2 July 2024 (Table 4.4, Figure 4.3). At both sites, surveys were primarily triggered by operational changes (e.g., inflating/deflating dams, dewatering fish ladders) or reduced flows overtopping the dams. Three surveys were conducted at the RD3 fish passage facility, with all three triggers related to dewatering the fish ladder (trigger code 8) and/or inflating/deflating the dam (trigger code 9). No stranded fish were observed in any of the surveys conducted at the RD3 fish passage facility. The other 18 surveys were conducted at the RD1 and BART Weir fish passage facility, with eight surveys triggered by reduced flows

overtopping the dam (trigger code 2), seven triggered by dewatering the fish ladder (trigger code 5), and three triggered by inflating/deflating the dam (trigger code 6). One stranded black bass was observed in late April during one of the eight surveys triggered by reduced flow overtopping the dam. No stranded fish were observed in the three surveys triggered by inflating/deflating the dam. Seven *O. mykiss*, one Pacific Lamprey, and two black bass were observed stranded in the RD1 fish ladder after it was dewatered (trigger code 5; Figure 4.4). Fish stranded in the RD1 fish ladder were "flushed" downstream, either by turning the ladder back on or by emptying buckets of water into the ladder from the grated walkway above. Three *O. mykiss* carcasses were observed and collected downstream of the RD1 fish ladder following stranding events. The three carcasses were scanned for but were not implanted with PIT tags. NMFS and CDFW were notified by ACWD immediately following all *O. mykiss* stranding events and carcass recoveries.

Though not recorded during a stranding survey and therefore not included in Table 4.4 or Figure 4.3, three additional *O. mykiss* were observed by ACWD and WRA staff during a predator/milling survey in the plunge pool downstream of RD1 on 22 March after it had become isolated (see Section 4.1.4 for details). These three *O. mykiss* and the seven observed during stranding surveys resulted in a total of 10 stranded *O. mykiss* observed between 4 January and 2 July 2024.

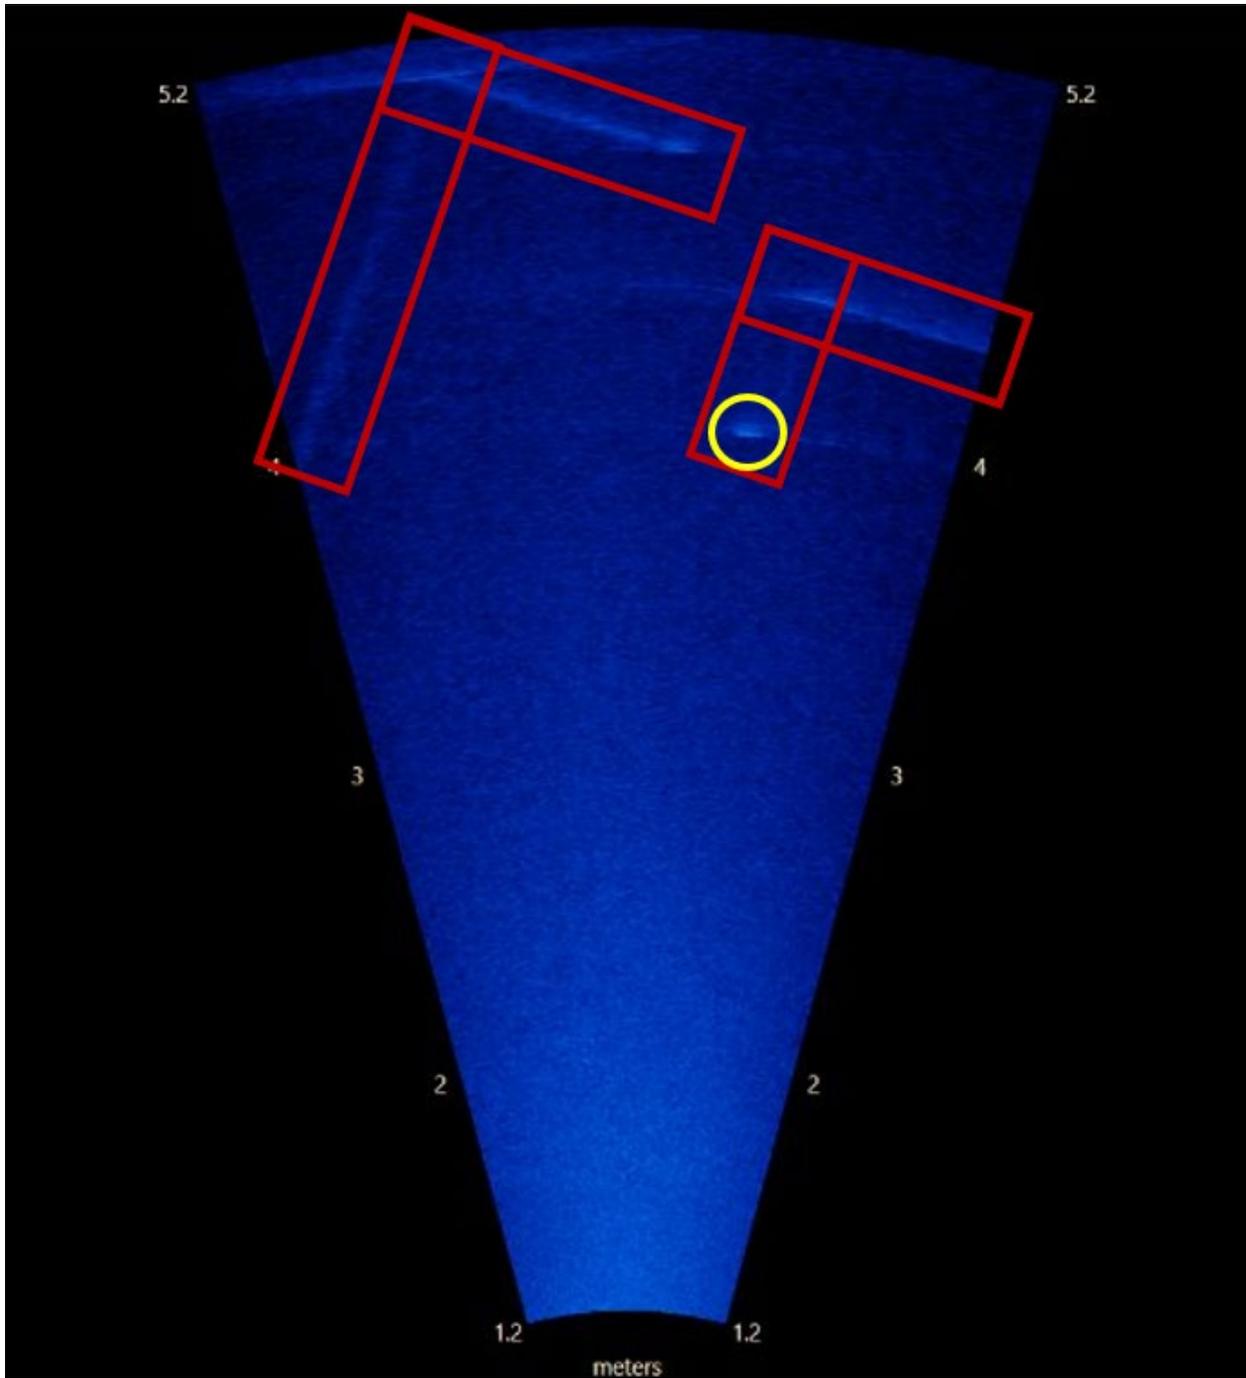
Figure 4.6: Sonar image showing the four walls used to assign qualitative image quality scores (red boxes) and the fixed target used to measure daily maximum energy levels (yellow circle).

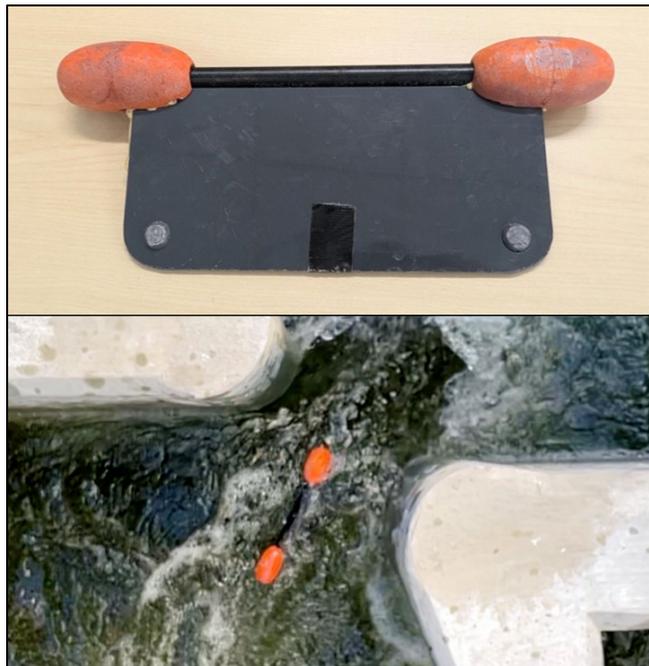
Figure 4.11: Customized float apparatus from West Fork Environmental to hold and orient PIT tags parallel to flow and perpendicular to PIT tag antennas for use in efficiency testing. The bottom photo shows the apparatus floating through one of the vertical slots of the RD1 fish ladder parallel with flow.

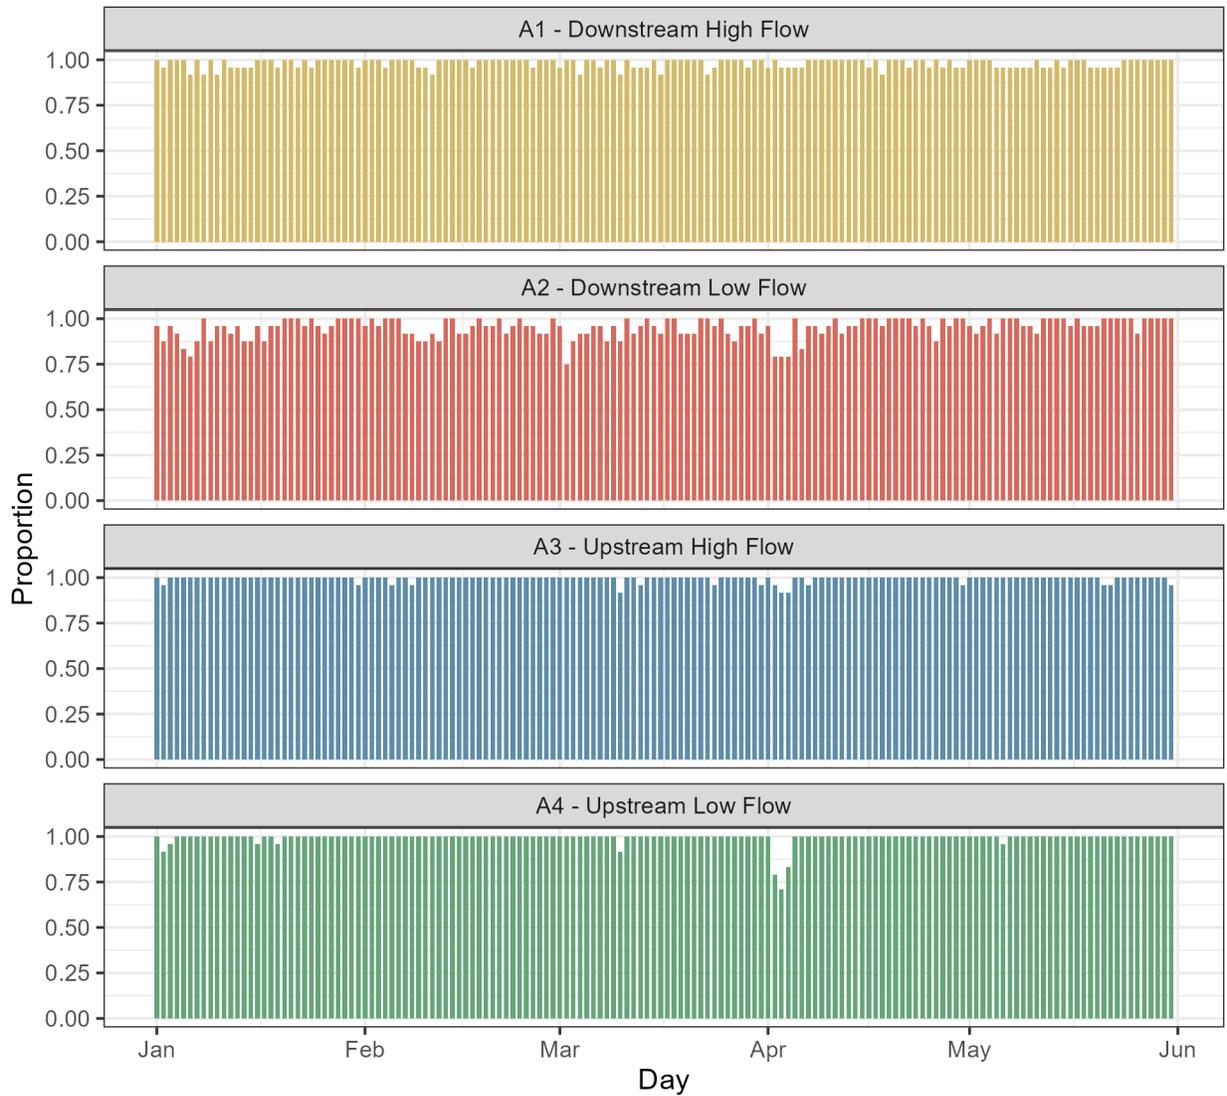
Figure 4.12: Proportion of expected hourly test tags detected by PIT tag antennas during the 2024 *O. mykiss* migration period. Relatively high proportions of detected test tags throughout the entire migration period confirmed that there were no significant periods (i.e., more than a few hours) when any of the antennas were not functioning.

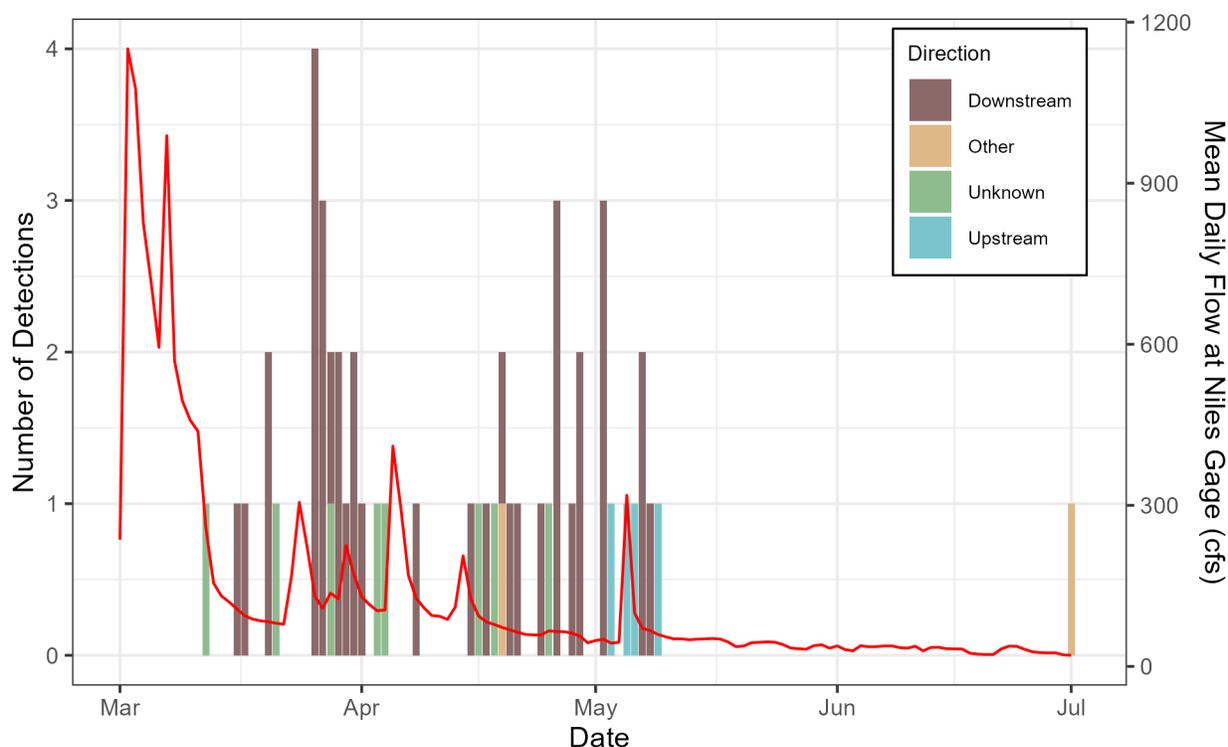
Figure 4.13: Number of PIT-tagged *O. mykiss* detected by the Project's PIT tag antennas by direction in 2024. "Unknown" directions are of fish only detected by one antenna, while "Other" directions are of fish detected moving in more than one direction.

PIT-tagged *O. mykiss* migrating through the RD1 fish ladder were detected as early as 12 March, with peak migration occurring in late March (Figure 4.13). Of the 51 PIT-tagged *O. mykiss* detected, 37 (73%) were detected by the upstream and then downstream antennas, confirming downstream migration. Four PIT-tagged *O. mykiss* were only detected moving upstream, with all four occurring in early May. Two PIT-tagged *O. mykiss* had more complicated detection patterns, including one fish detected moving downstream and then back upstream less than five minutes later on 19 April 2024. The other fish made several upstream and downstream movements between 1 and 3 July during an experimental pulse flow (see Section 4.5 for more details). Eight PIT-tagged *O. mykiss* were only detected on one antenna and therefore their direction could not be confirmed. All but one of these fish were only detected at the downstream antenna, suggesting that they either migrated through the fish ladder but were missed by the upstream antenna, or that they had migrated over RD1 instead of through the ladder, migrated back upstream through the ladder to the downstream antenna, and then turned around before passing through the upstream antenna.

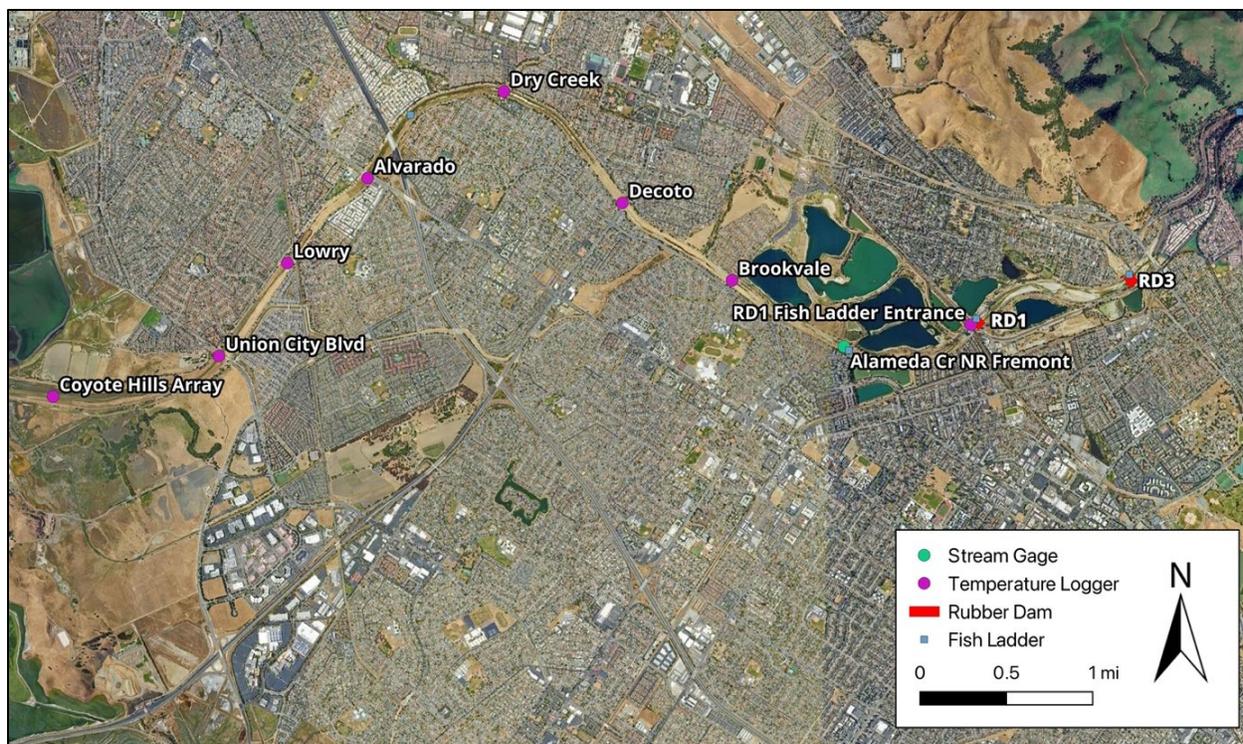
Figure 4.15: Map showing locations of temperature loggers and USGS stream gage (11179100) downstream of RD1 and RD3 impoundment footprints.

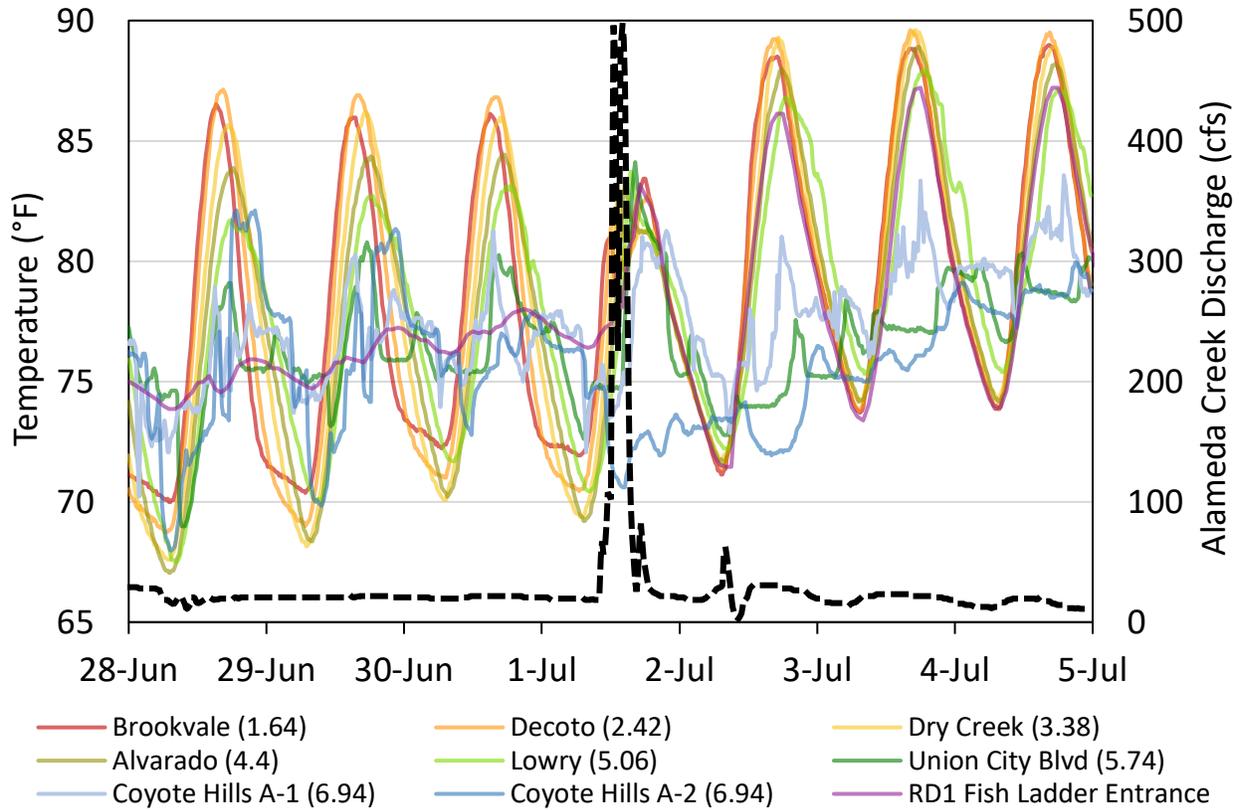
Figure 4.16: Water temperature (color lines) and flows (dashed black line) downstream of the RD1 fish ladder before and after the experimental pulse flow (1 July). Numbers in parentheses refer to the number of river miles each logger was located downstream of the RD1 fish ladder. The Coyote Hills A-1 logger was deployed near the water surface, while the A-2 logger was deployed near the bottom of the water column.

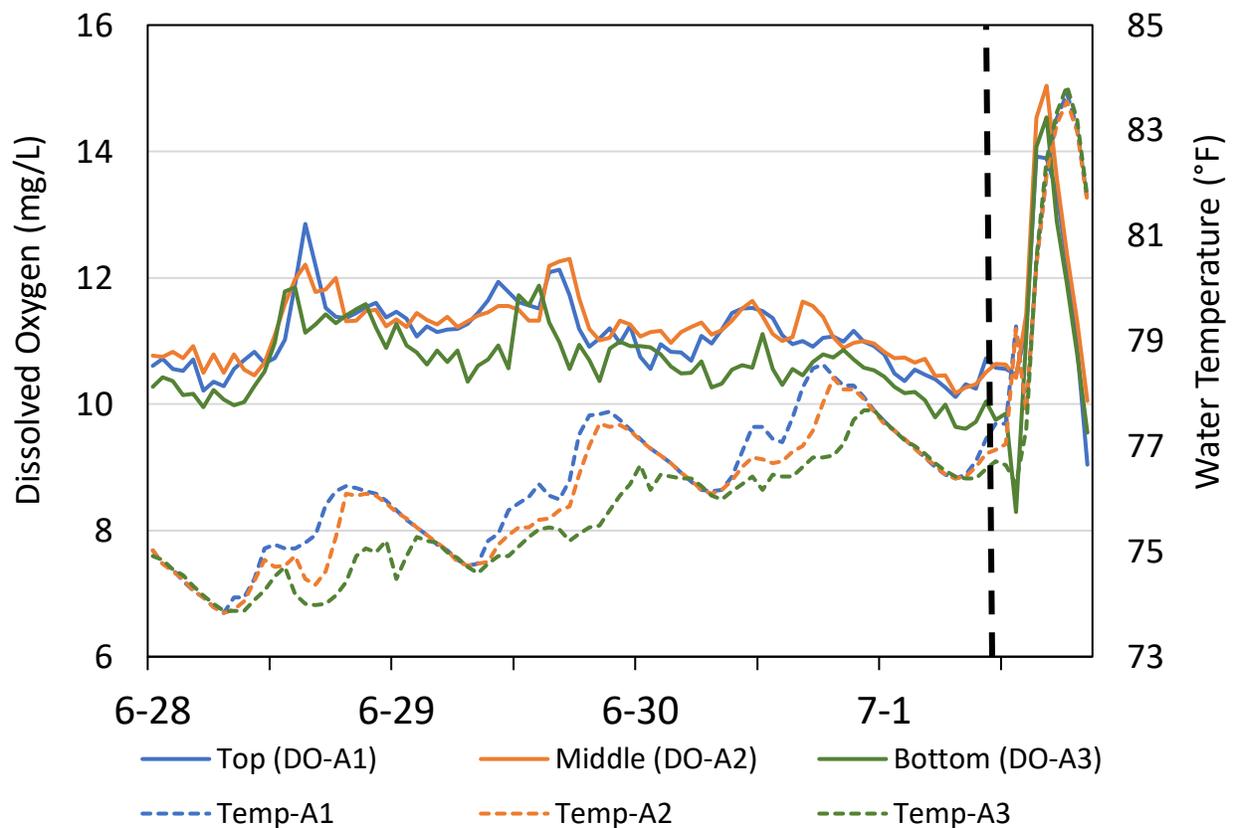
Figure 4.17: Water temperature and dissolved oxygen concentrations within the RD1 fish ladder before and during the experimental pulse flow (1 July). The dashed vertical line indicates 1 July 2024 at approximately 10:15 when the experimental pulse flow began.

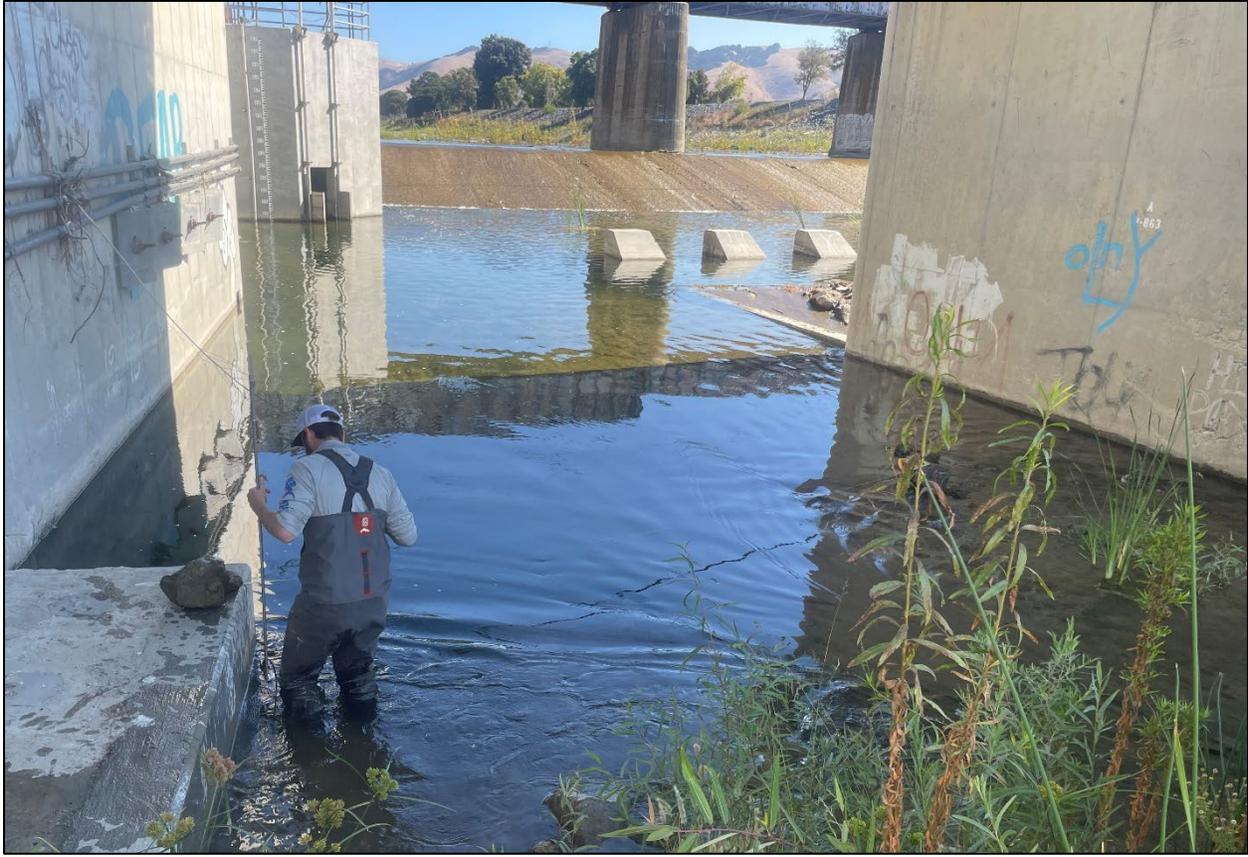
Figure 4.18: Flow transect conducted above the lower fish ladder on 26 September 2024 when flows at the USGS Alameda C NR Niles CA - (11179000) stream gage measured 35 cfs.

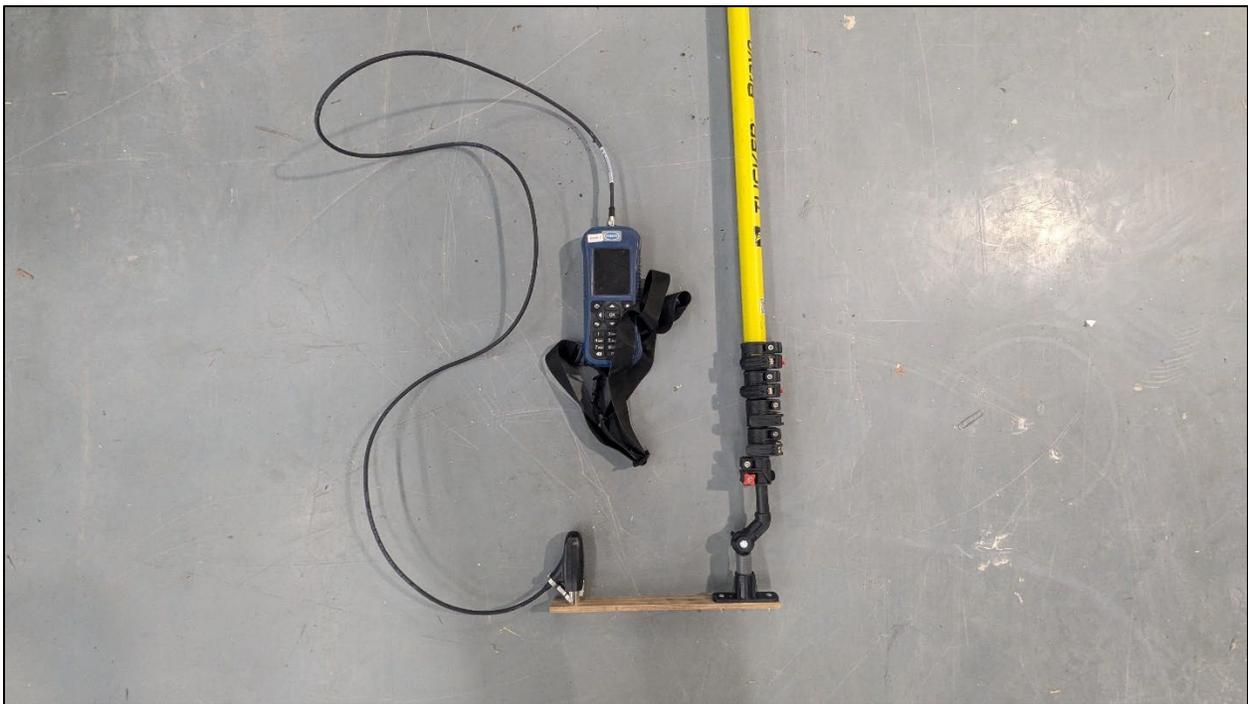
Figure 4.19: Hach FH950 handheld flow meter vertically attached to a telescoping fiberglass pole used for measuring approach velocity at ACWD's Bunting Pond diversion fish screen.
